Merrifield North Employment and Beveridge  
South West PSP Pre-European Wetland  
Investigation

July 2024

This report has been prepared by Alluvium Consulting Australia Pty Ltd for Melbourne Water under the contract titled 'Merrifield North Employment and Beveridge South West PSP Pre-European Wetland Investigation.'

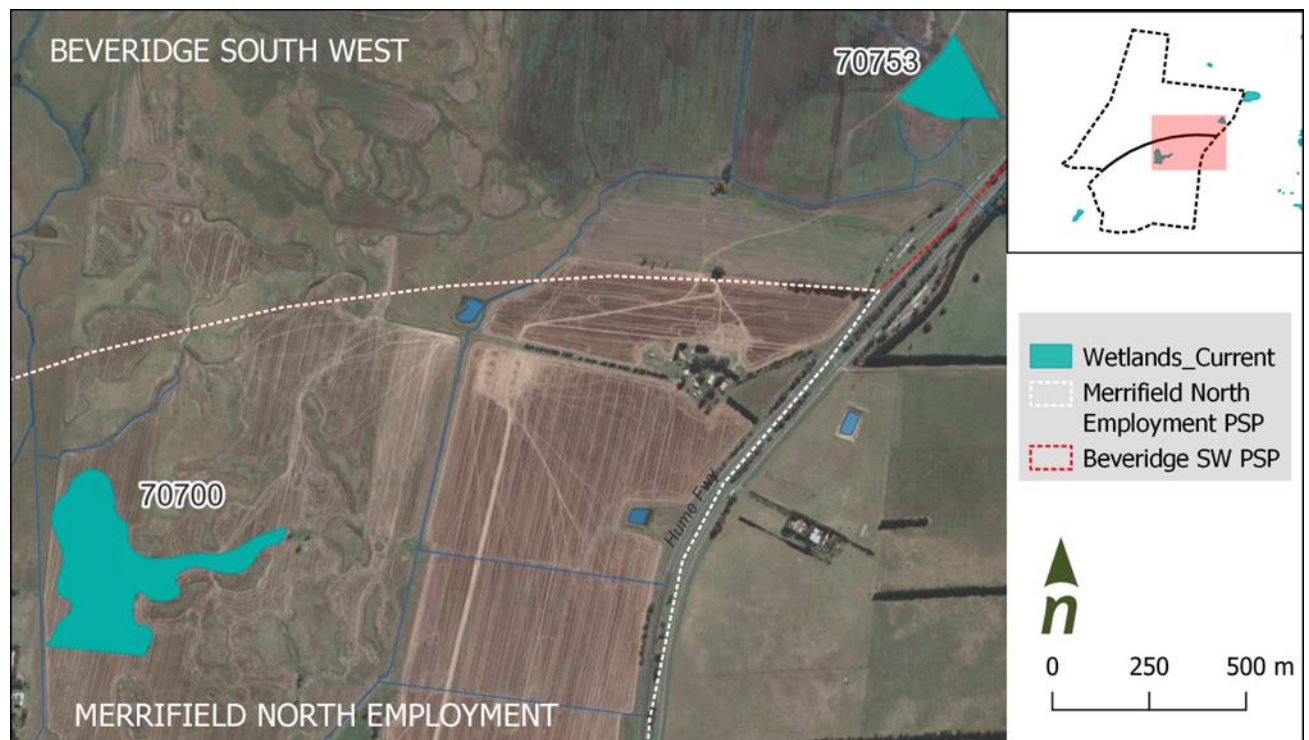
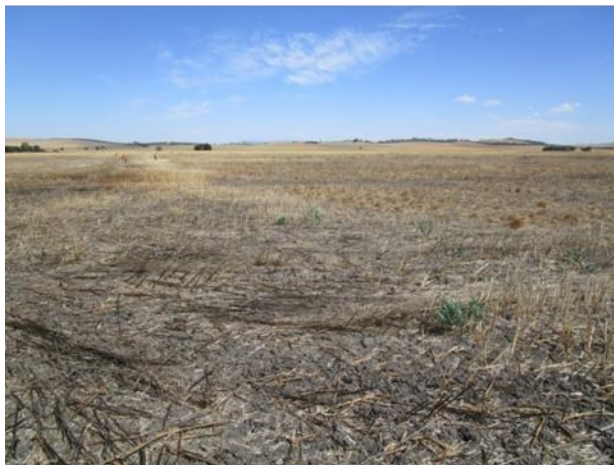
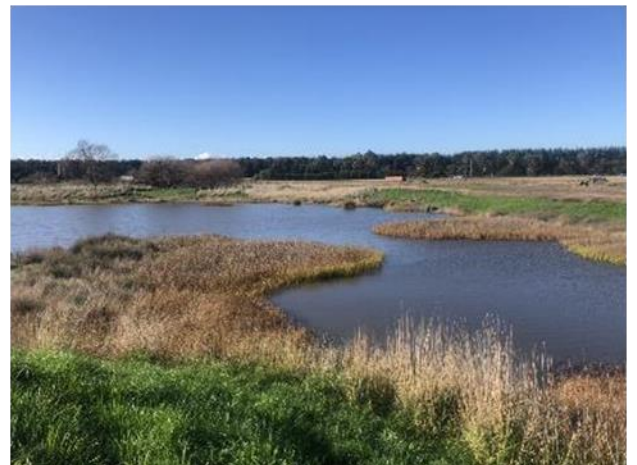
**Figure 2.** Current wetlands in the PSP area.

The only EVC listed for the extent of the wetland was **Unclassified (Crop) EVC 999** which covered 100% of the area. The historic EVC (listed as Plains Grassy Wetland) was scored as completely displaced with no species that define the Plains Grassy Wetland EVC currently present in the landscape. The overall condition of the mapped wetland 70700 is assessed at the very low end of Poor, with the biota component achieving a score of 'Very Poor' due to its total conversion to cropping and lack of species characteristic of the prior EVC and dependant on at least periodic inundation. The only evidence of a wetland influence could be seen in the areas of canola crop failure across the site. These patches likely represent patches of inundation beyond the tolerance of the canola crop.

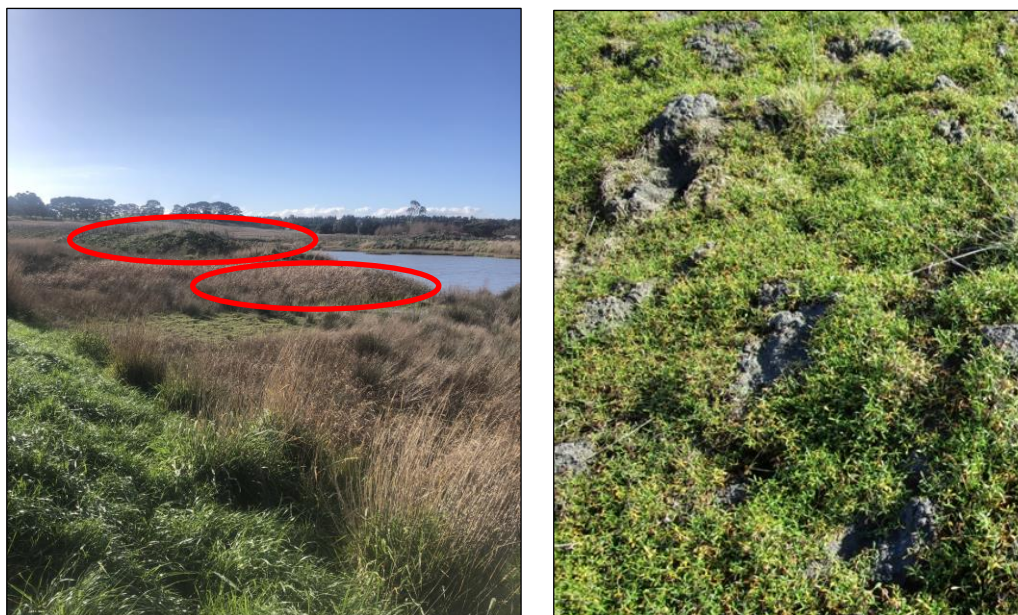
**Figure 3.** Left- Wetland 70753 with mounds dumped highlighted, right - *Ranunculus diminutus* (Brackish Plains Buttercup) patch.

Disturbed/weedy areas were not distinguished as a separate zone due to patchiness of distribution of native species across the wetland. Despite the presence of native flora within the wetland, the low cover and density of native obligate wetland flora and high cover of weeds (due to disturbance) resulted in a biota score of 'Very Poor' for the wetland. Despite the low overall score, two patches of FFG Act listed endangered *Ranunculus diminutus* (Brackish Plains Buttercup) were noted adjacent to one of the dammed walls of the wetland. The overall condition of the mapped wetland 70753 was assessed as 'Poor'.

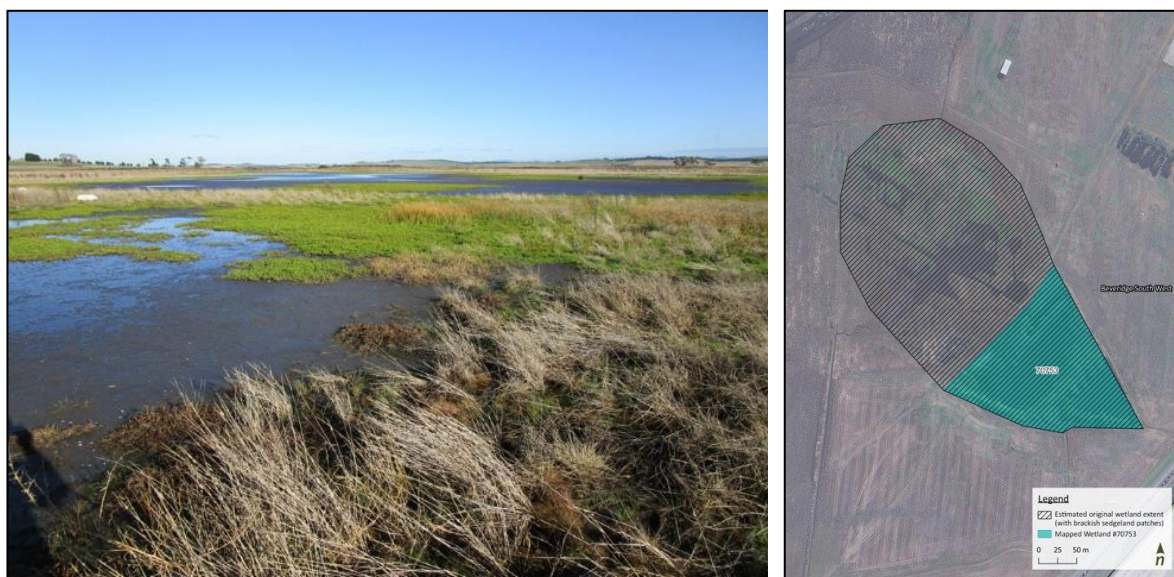
**Figure 4.** Left- Image Wetland extension to the northwest of the mapped Wetland 70753. Easting 0319611; Northing 5848720, right- Mapped extent of estimated wetland area including inundated patch.

To the northwest of the mapped 70753 wetland is a further wetland area, estimated to encompass the original wetland extent (Figure 4). The wetland contains patches of Brackish Sedgeland EVC 13. No formal IWC assessment has been done on this patch however due to the relatively minimal amount of excavation within the wetland, it should be considered in future planning.

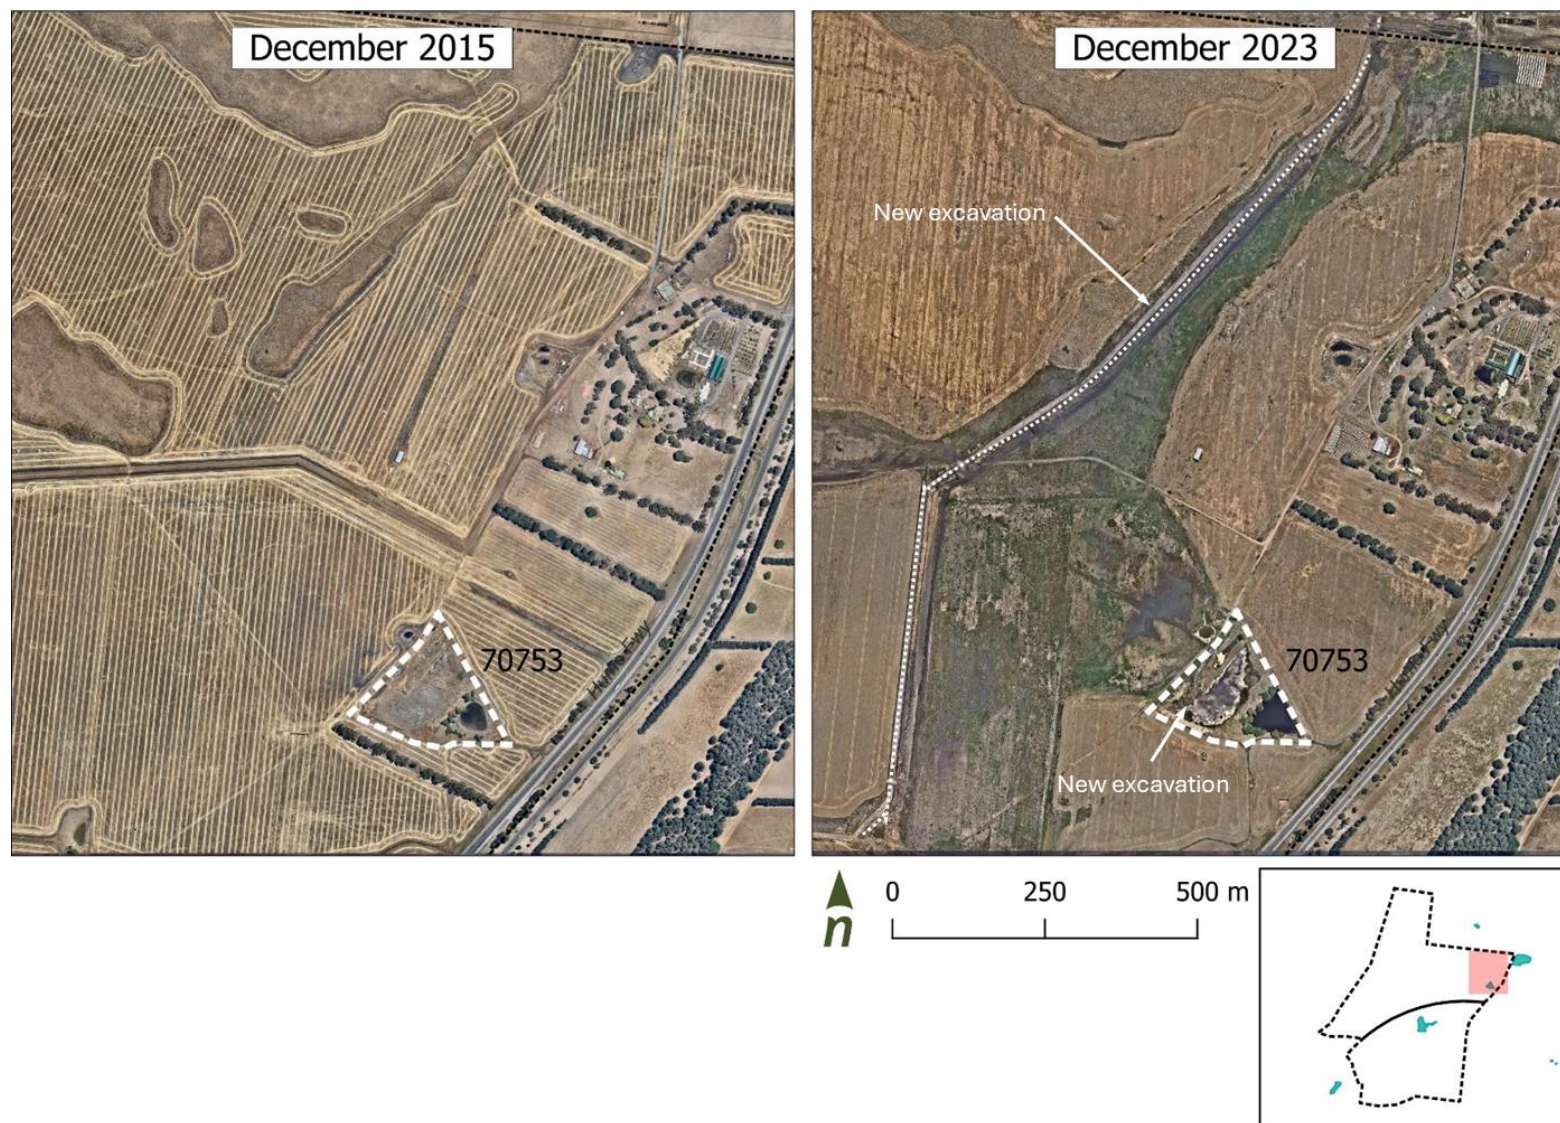
**Figure 8.** Aerial images of wetland 70753 from 2015 (left) and 2023 (right) with recent drainage line and wetland excavation annotated.

Inspection of aerial imagery revealed that drainage lines have been to the north of wetland 70753 (Figure 9), along the approximate natural flow path that feeds surface water towards the area surrounding the wetland (see Figure 28 for an overview of these flow paths). The excavation and mounding of material from within the mapped footprint of the wetland observed in the field (see section 2.2) is also evident in the 2023 aerial image in Figure 8.
