**Merrifield North Employment and Beveridge  
South West Precinct Structure Plans**

Geomorphology and vegetation  
assessments – Final

April 2024

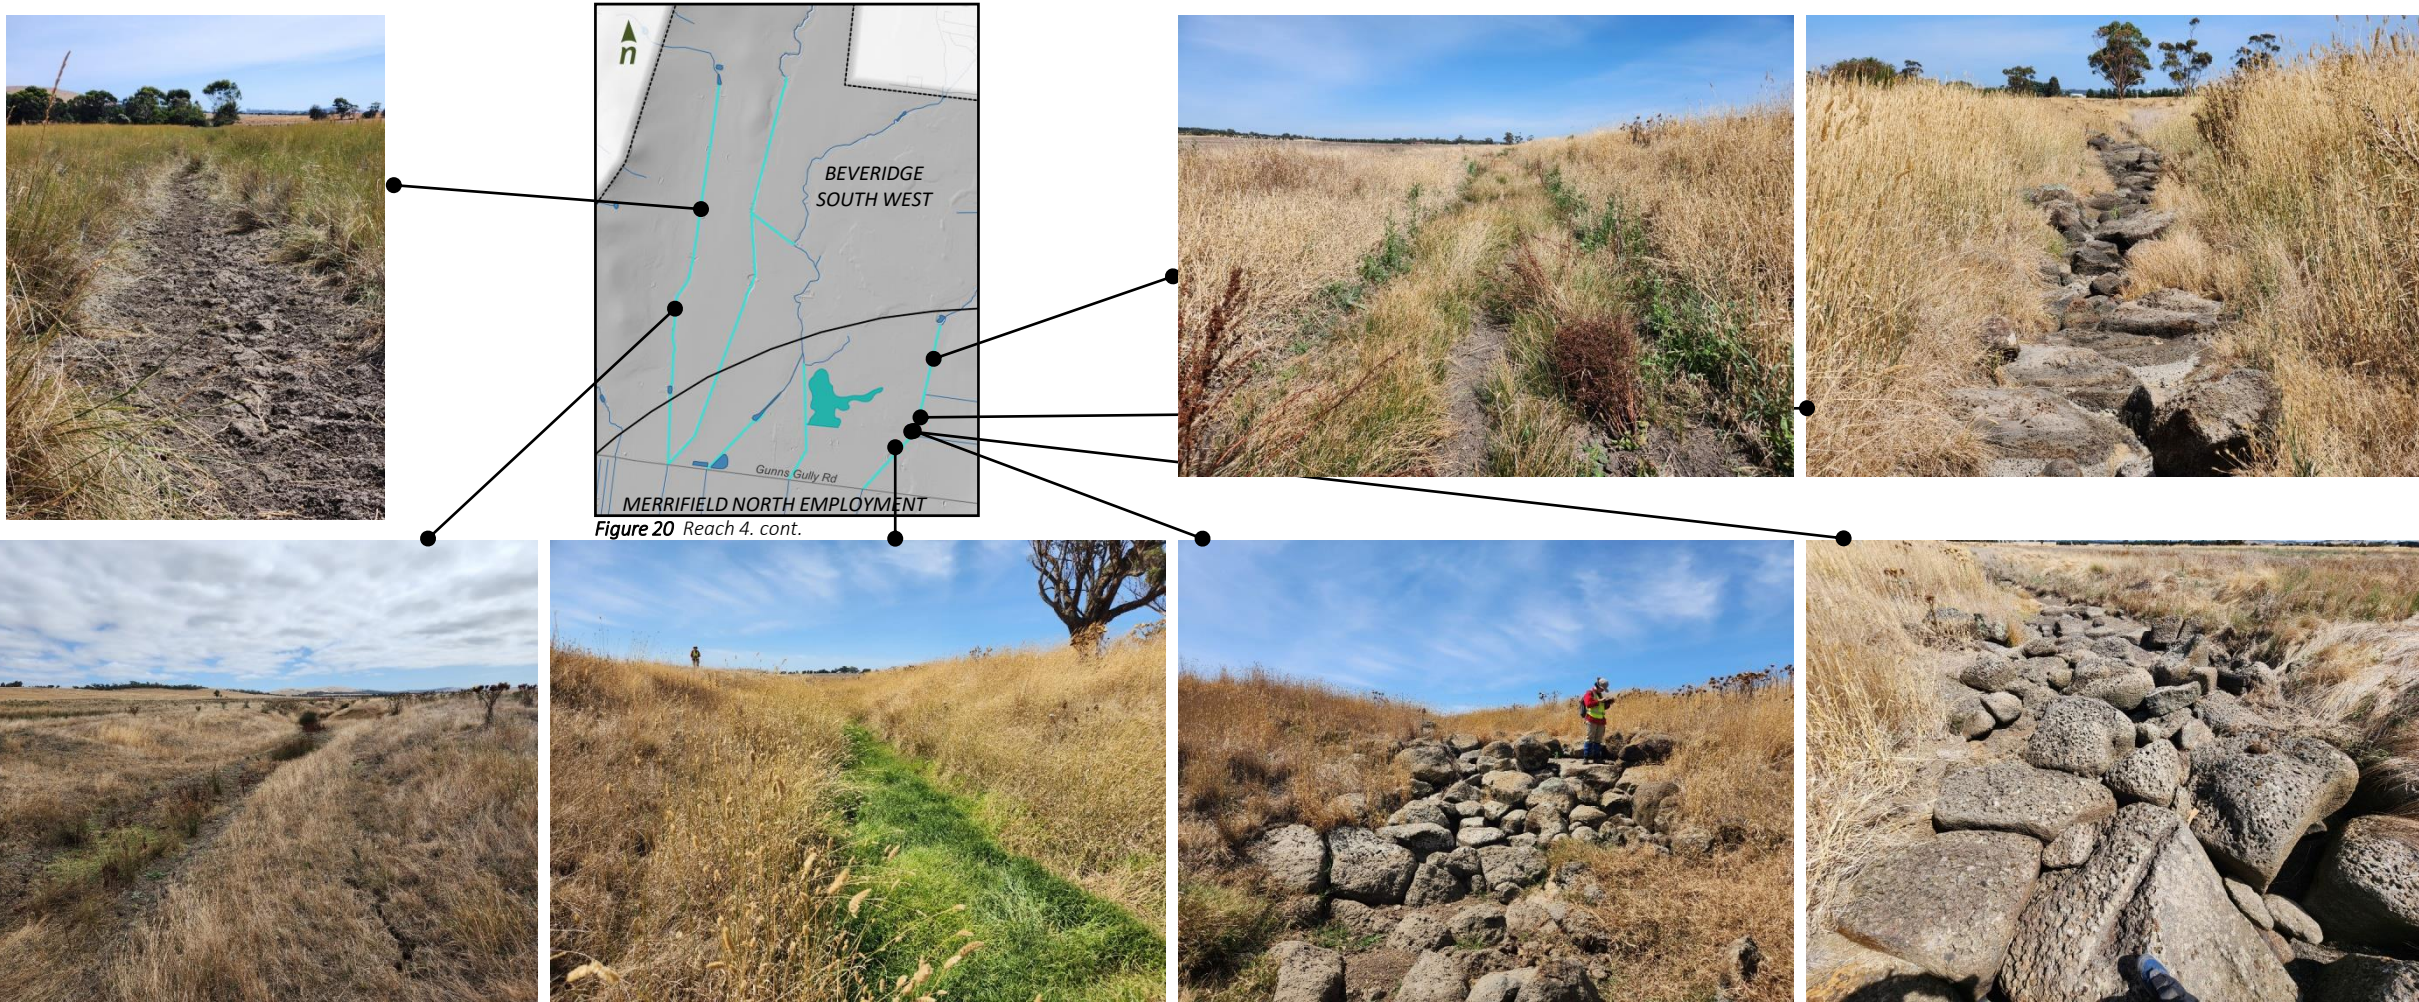
## Reach #4 – Eastern and western channels

*Straight channels of varied depth and width with graded, banks. Banks typically vegetated with perennial pasture grasses and thistles. Channel vegetation varies from bare trampled soil, to rushes, to perennial grasses.*

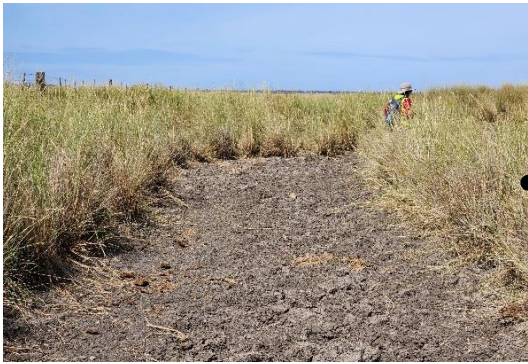
Riparian vegetation is dominated by exotic Tall wheatgrass. Patch of Tall Wheat-grass *Lophopyrum ponticum* (syn. *Thinopyrum ponticum*) population found around dam - FFG Act 1988 listed as a potentially threatening process.

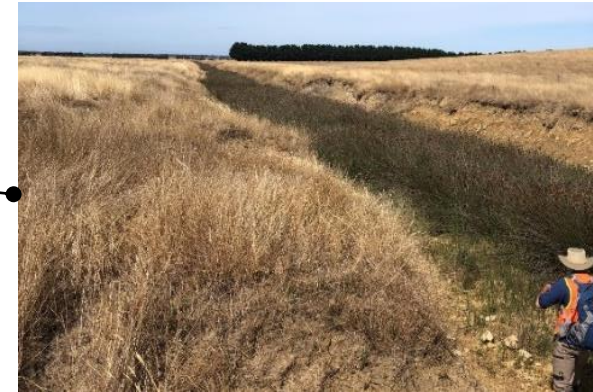
South facing image with scattered VVP Plains Grassland species around 20m on the western flank of the creek may expand beyond the area surveyed. A full assessment of the extent and quality of VVP Grasslands is recommended.

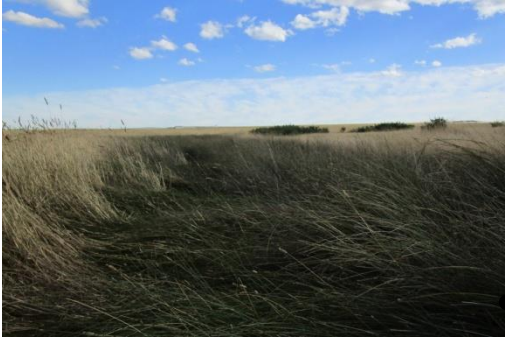
Band of Poong'ort (*Carex tereticaulis*) sedgeland on west side of creek.

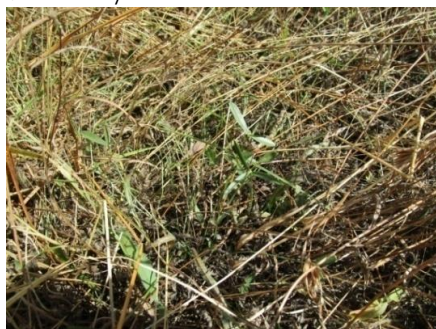
Image description: *Cullen tenax* (narrow green leaflets in the centre of the image) within remnant patch of *Themeda triandra* grassland/ Stony knoll shrubland. This taxon is listed as Endangered on the FFG Act 1988 Threatened List.

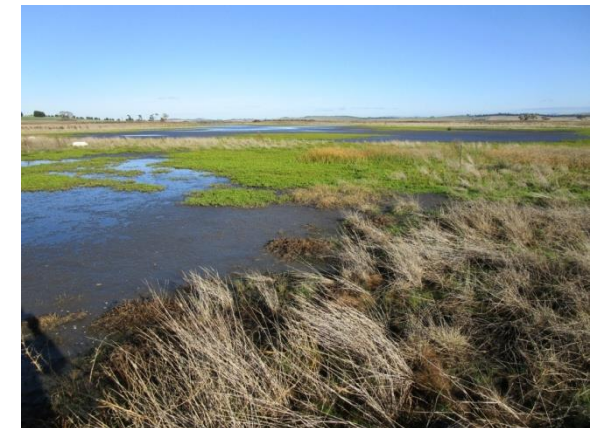
The most abundant species was introduced Water Buttons (*\*Cotula coronopifolia*) locally providing c. 80% cover. Other species observed include Small Loosestrife (*^Lythrum hyssopifolia*), Wimmera Rye-Grass (*\*Lolium rigidum*), Annual Beard-grass (*\*Polypogon monspeliensis*) and Fat hen (*\*Chenopodium album*). The inundation prone area was surrounded by land cropped for wheat.

Inundation prone area adjacent to the area mapped as wetland 70753.

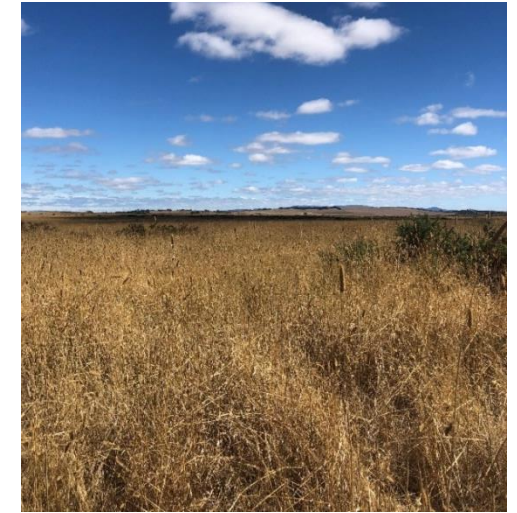
Patch of Heavier Soils Plains Grassland EVC 132\_61 with a distinct species mix compared to the remnant patch in the west of the conservation reserve.
