# Croskell PSP Proposed Drainage Strategy

## Feature Survey Report

Prepared for Melbourne Water

Prepared by Water4Good

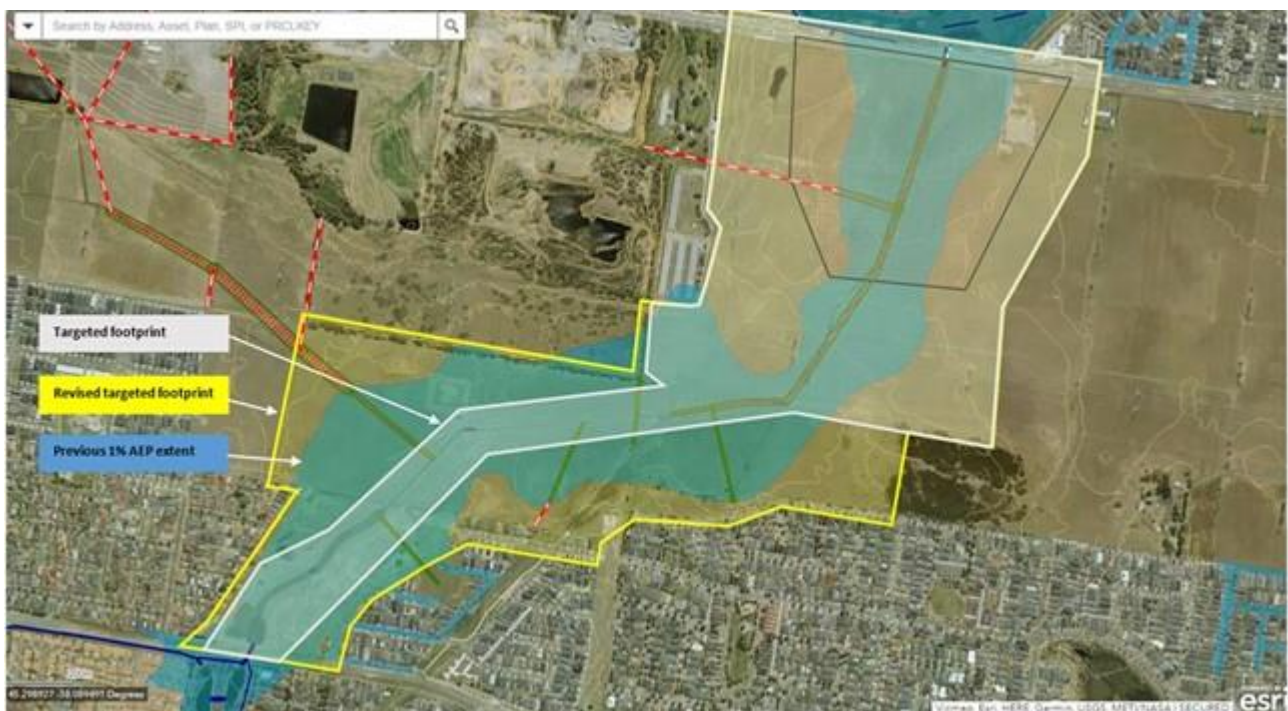
Figure 1: Extents of survey shown in White Polygon

To inform functional design requirements a feature and level survey was completed of areas within the white polygon shown in figure 1. The survey was performed via ground-based GPS observations and supported by the deployment of an Unmanned Aerial Vehicle (UAV) fitted with a Riegl MiniVUX 2 LiDAR sensor in order to capture site topography which was of particular benefit through vegetated areas where pedestrian access was heavily restricted.

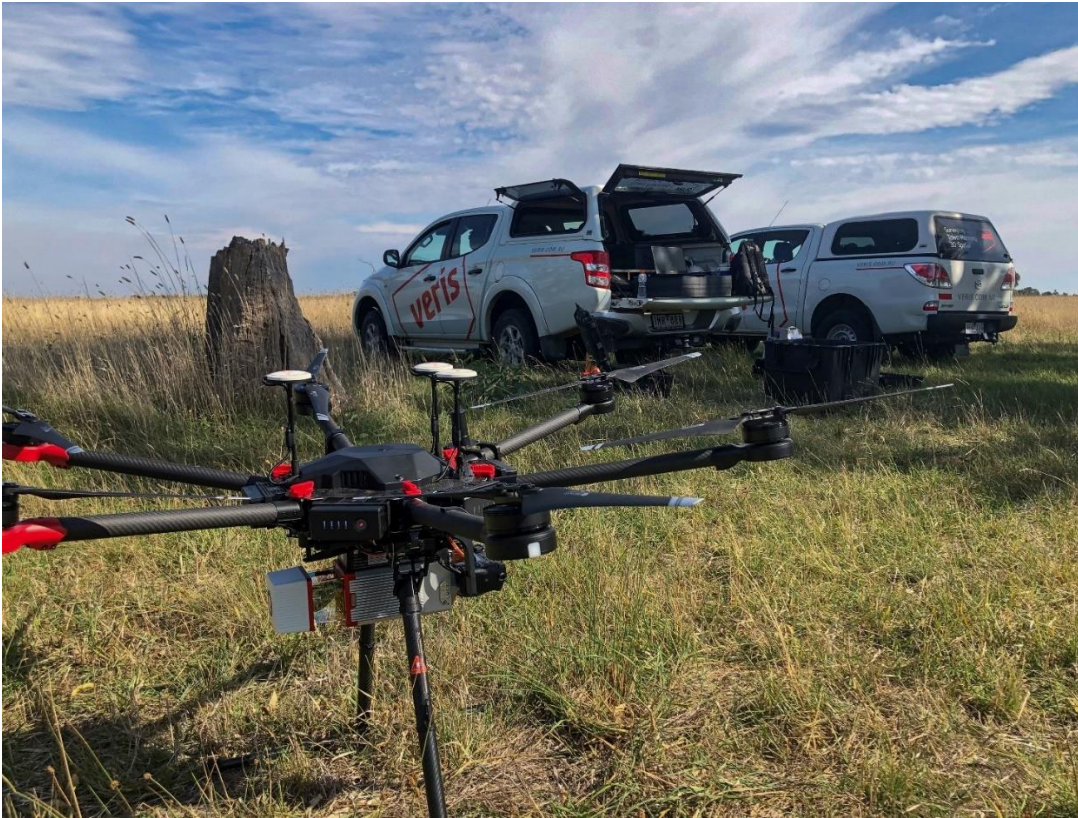
Figure 2: Riegl MiniVUX LiDAR UAV in preparation for takeoff.

A DJI M600 UAV carrying a Riegl MiniVUX2 LiDAR sensor collected full wave form point-cloud data of survey extents. In unison with the LiDAR capture, nadir georeferenced photography was used to produce an RGB Orthorectified Aerial Image.

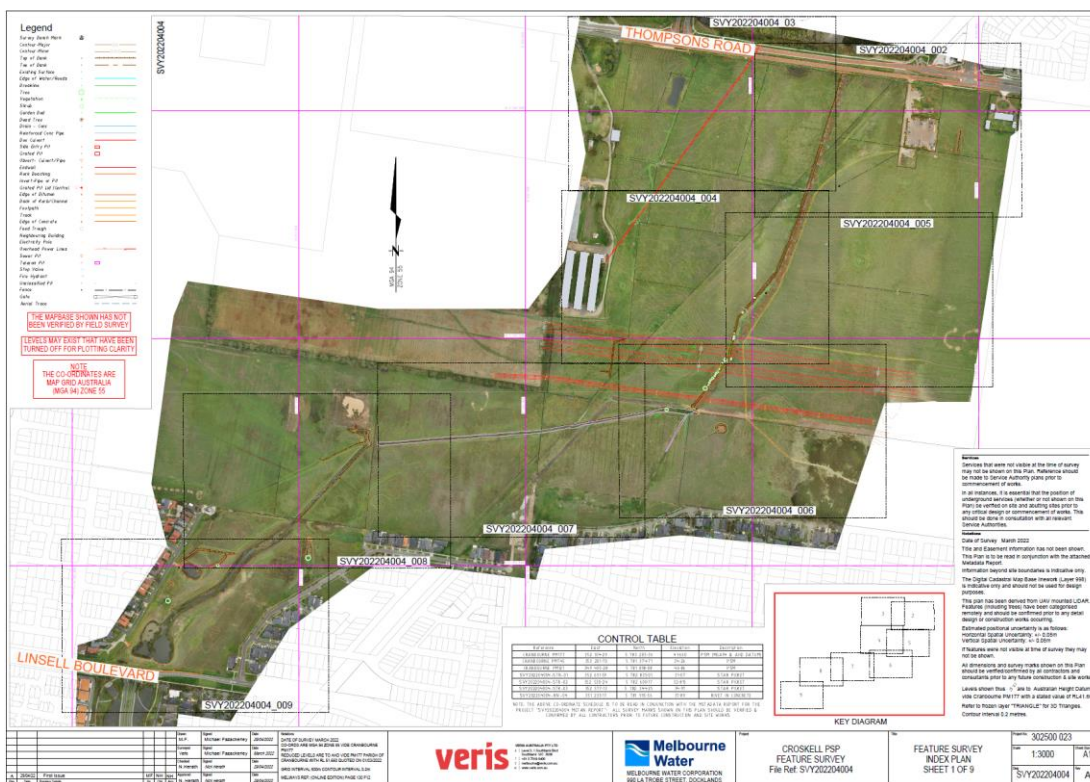
Figure 3: Coversheet of feature survey with project extents
