# Merrimu PSP

Final geomorphology and  
vegetation assessment

November 2019

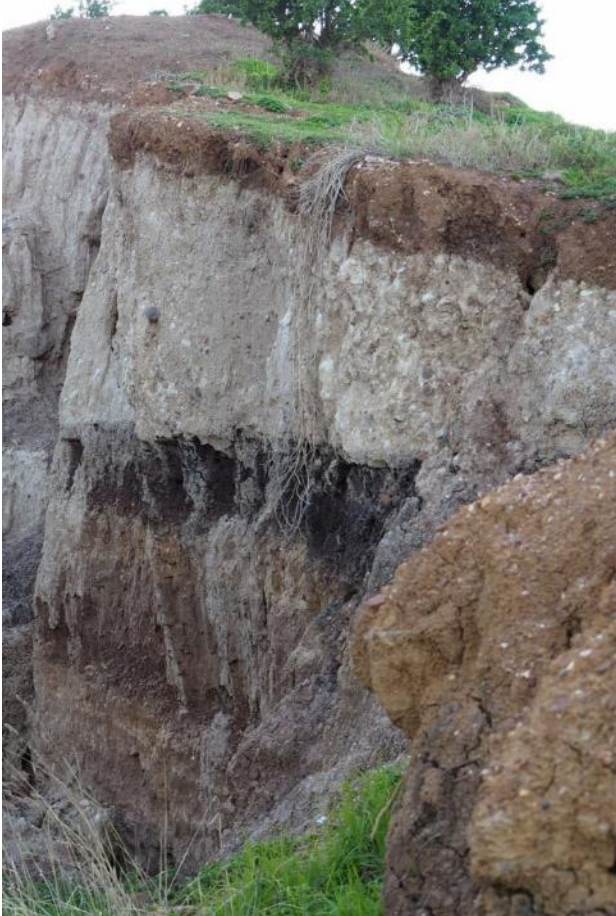
**Figure 5.** Soil profile typical of soils associated with the Werribee Formation.

Across the PSP area, soils have been classified according to the Australian Soil Classification as Sodosols. Sodosols are soils that have a strong texture contrast between the A and B horizons with the upper 0.2 m of the B2 horizon being sodic. Piping or tunnel erosion is very often associated with dispersive sodic soils (Ford et al. 1993).

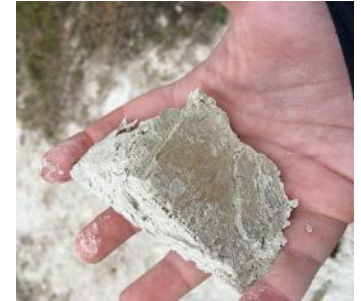
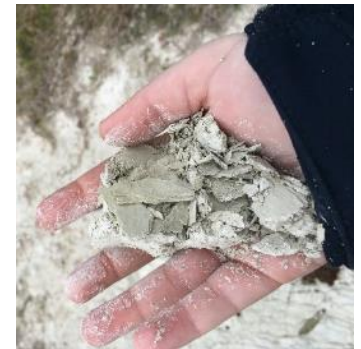
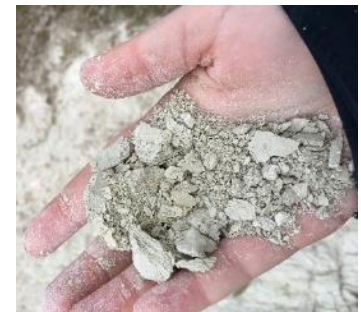
**Figure 6.** The bleached horizon of soils associated with the Werribee Formation is fine textured and fragile. Soil structure crumbles easily in the hand.

Soils of the Werribee Formation have a well developed horizon differentiation and are a light coloured, sandy texture. These soils are highly dispersive due to their high sodium content. Erosivity is further enhanced by low fertility and the development of a hard surface layer which limits vegetation development. These soils are among the most erodible in Victoria (Earth Tech 2006).

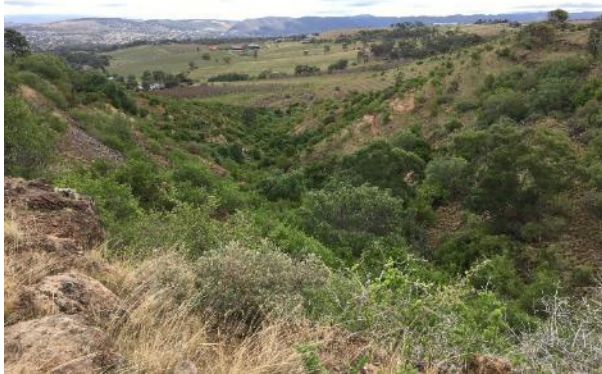
Tunnel erosion is a common feature at sites on the Werribee Formation.

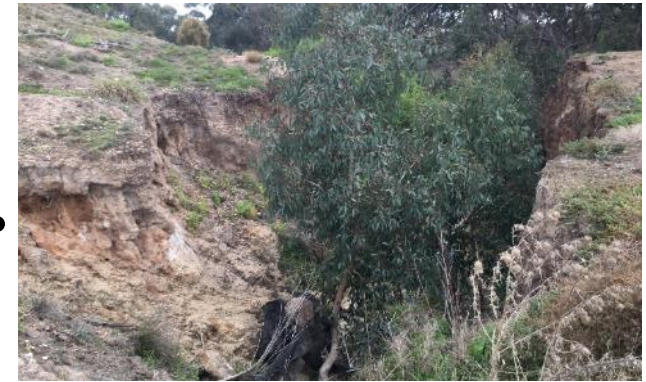
Steep headwaters have steep bed and bank slopes draining off the escarpment. Waterways with good vegetation cover are in better condition than those with poorer vegetation cover where erosion is extensive.

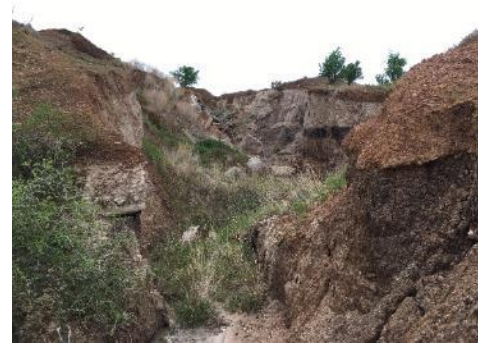
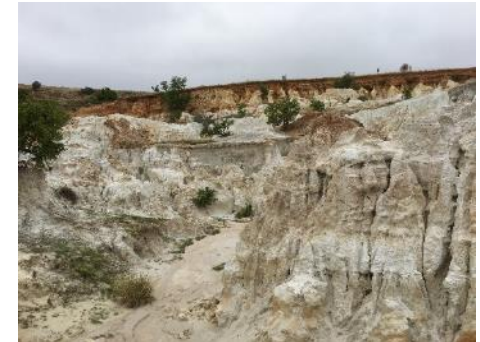
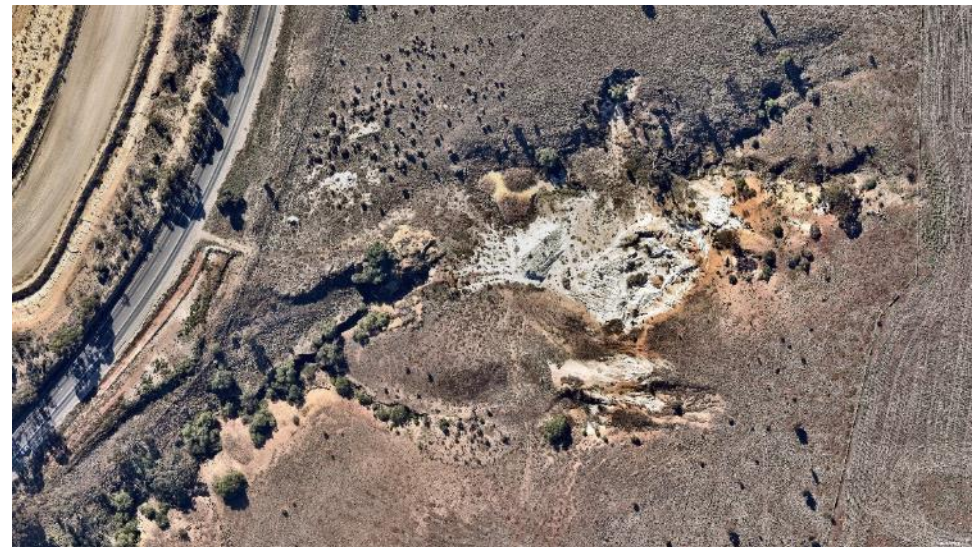
# Steep headwater on the Werribee Formation #1

**This waterway is a headwater stream that has been subject to significant erosion.** The lower section of the waterway is deeply incised and in its upper extent, there is significant gully development. Tunnel erosion is evident in many places and is made possible by the dispersive soil found across the site.

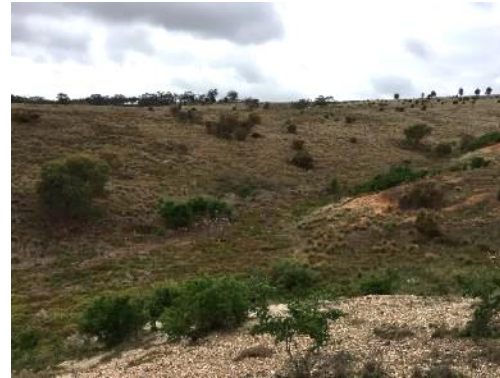
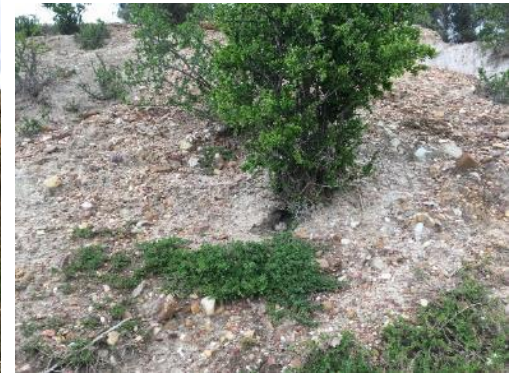
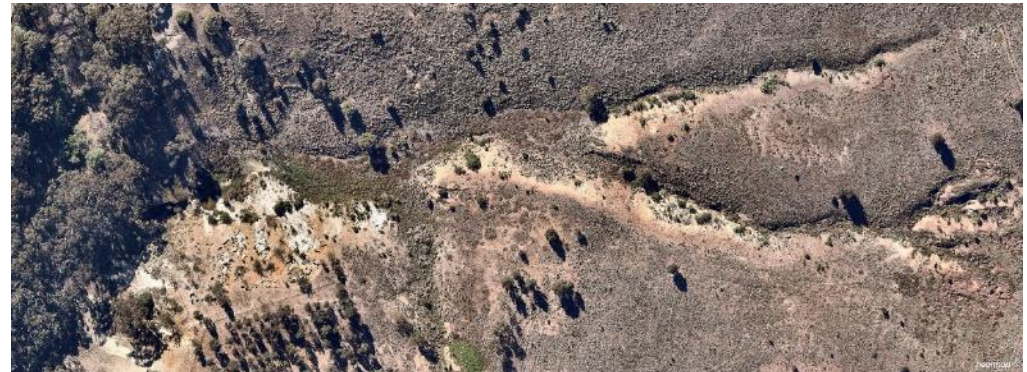
# Steep headwater on the Werribee Formation #2

**This waterway is a headwater stream that shows evidence of active erosion processes.** The upper reach is steep as it flows from the top of the escarpment, however the slope of the bed and bank becomes gentler downstream. Like the nearby site, erosion processes are active with dispersive soil playing a large part in these processes.

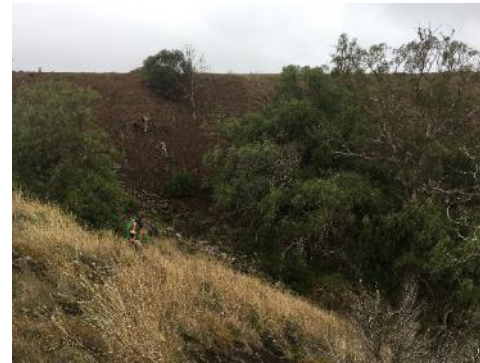
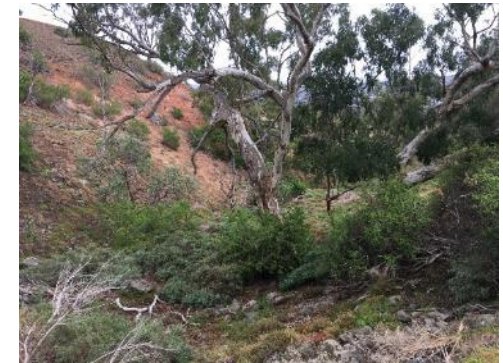
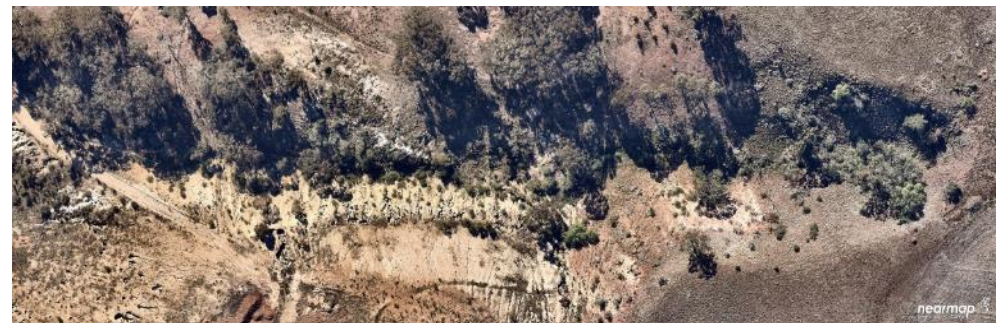
# Steep headwater on the Werribee Formation #3

**This waterway is a well vegetated headwater stream.** The upper reach is very steep and rocky as it flows from the top of the escarpment, however the slope of the bed and bank becomes gentler downstream. Erosion processes appear to be relatively limited at this site.

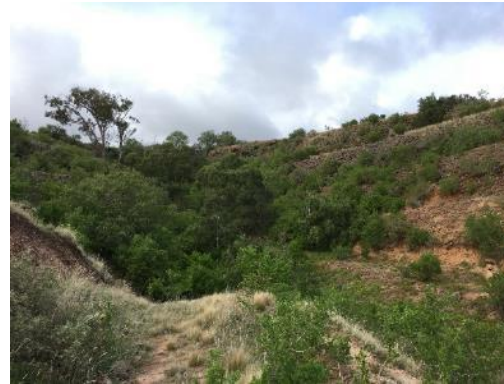
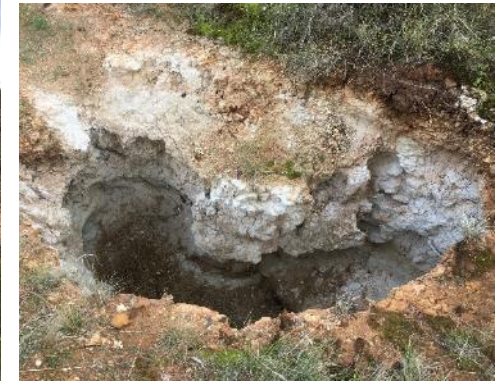
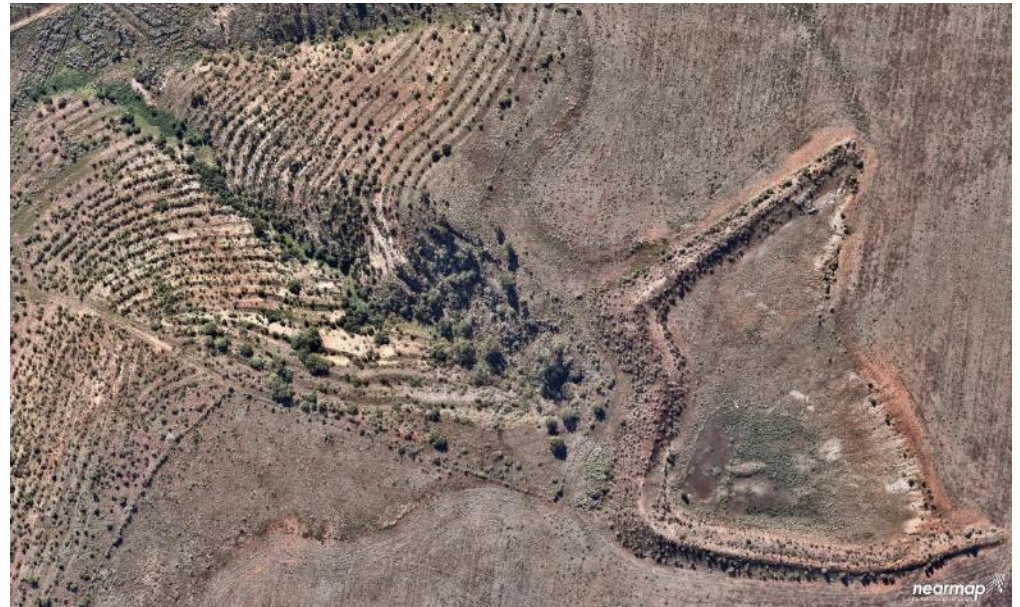
# Steep headwater on the Werribee Formation #4

**This waterway is a steep headwater stream that flows off the escarpment over a terraced slope.** At the upstream extent of the waterway there is dam that was likely to have been constructed to control the flow of water off the slope. Both the dam and the terracing at this site may be an indication of past attempts at stabilising the site. Tunnel erosion is evident at the site and the soil characteristics mirror those at other sites on the Werribee Formation.

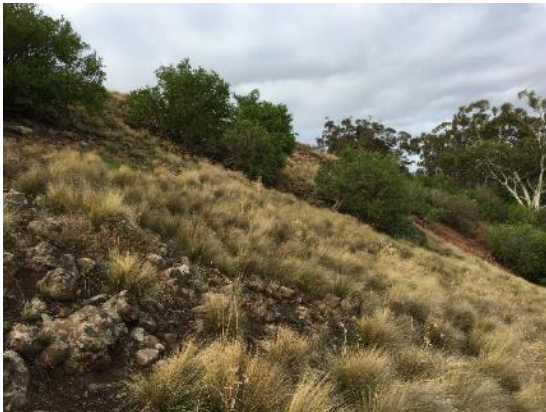
This steep headwater on the Castlemaine Group is well vegetated by woody weeds and grasses. Valley sides are very steep, however large boulders are present throughout the reach. These well vegetated, rocky slopes display minor evidence of erosion.

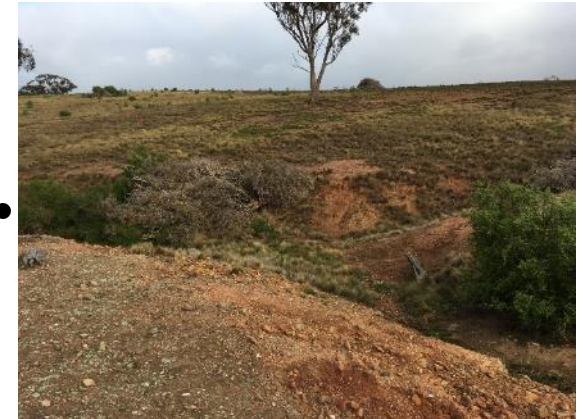
The upper reaches of these waterways are cleared and display more evidence of instability than the lower, better vegetated reaches.

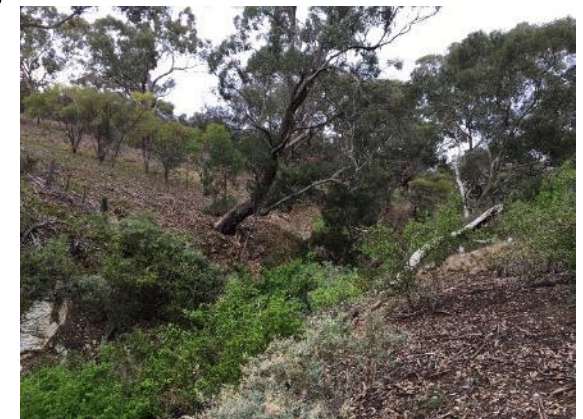
This steep headwater stream is well vegetated with tress and woody weeds. Erosion processes are limited here with frequent occurrences exposed bedrock throughout the reach.

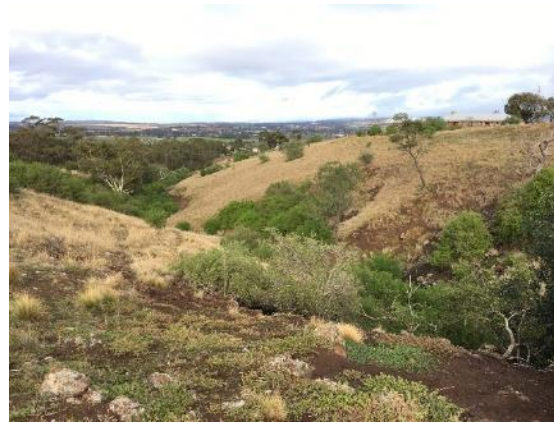
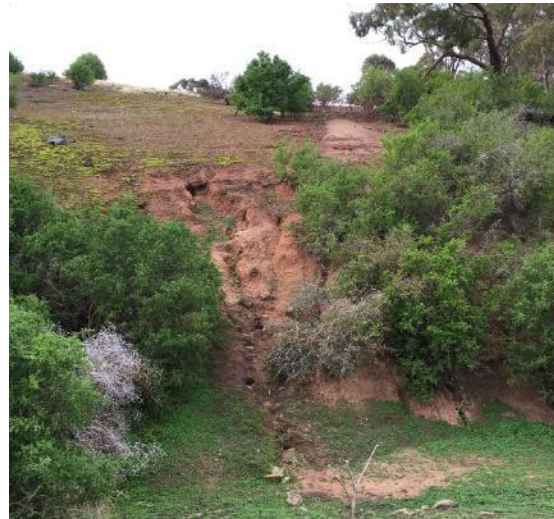
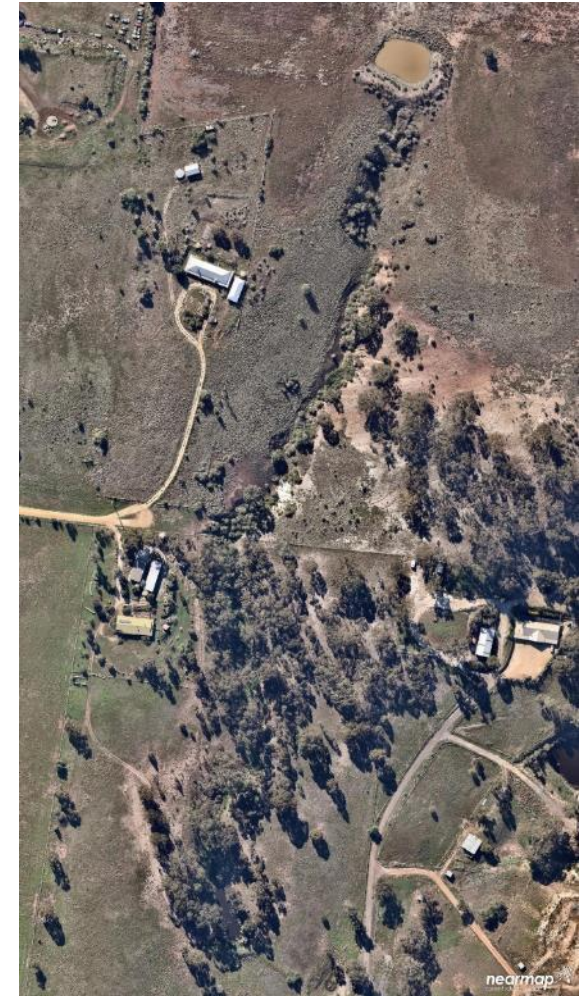
**This waterway is a steep headwater stream that flows off the escarpment in a southerly direction.** At the upstream extent of the waterway there is dam that controls the flow of water into the waterway. The waterway is fully confined between steep valley sides. Large boulders are common along the upstream reach of the waterway. Like other sites, there is evidence of tunnel erosion processes at the site. Although still sodic in nature, the soils appear less fragile than those found on the Werribee Formation.

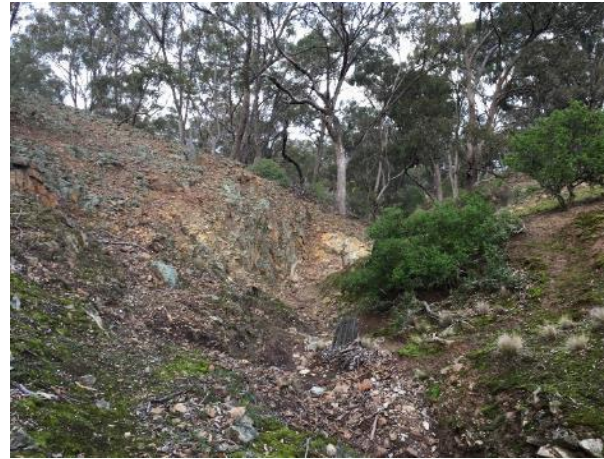
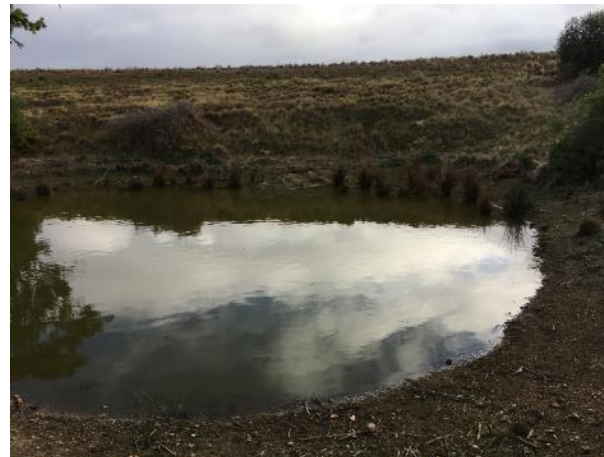
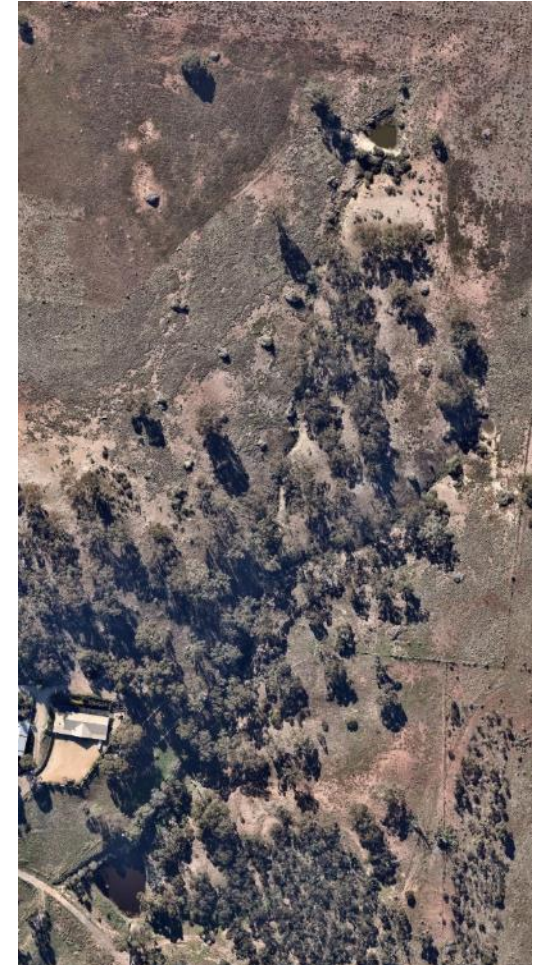
# Steep headwater on the Castlemaine Group #2

This waterway is a steep headwater stream that flows off the escarpment in a southerly direction. At the upstream extent of the waterway there is dam that controls the flow of water into the waterway. The waterway is fully confined between steep valley sides. Unlike the neighbouring waterway, it is relatively well vegetated. Large boulders are common throughout as is exposed bedrock. There is limited evidence of erosion at this location.

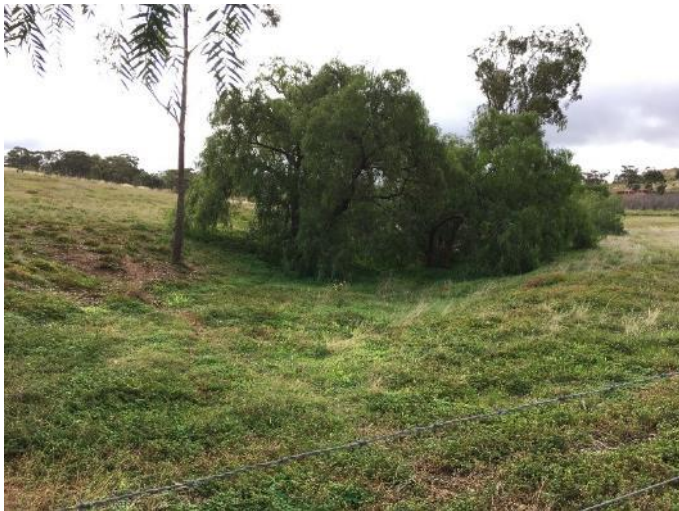
The waterway is partly confined by the steep slope of the escarpment. The waterway is heavily vegetated with trees throughout the channel, however the adjoining landscape is cleared agricultural land.

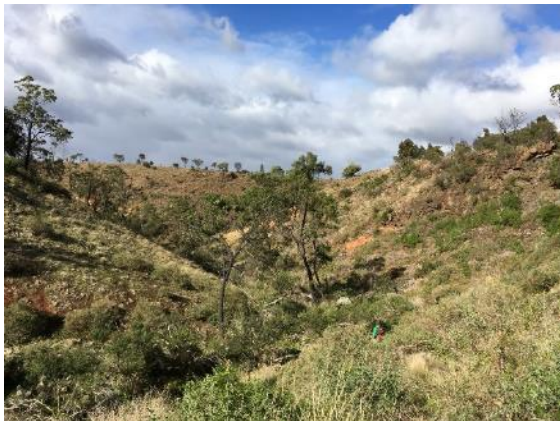
The upper reaches of the steep headwater streams on the eastern escarpment are somewhat cleared compared with the lower reaches of these waterways.

The streams are very steep as the flow off the escarpment. They are confined by steep valley sides and large boulders are frequently found throughout these waterways.

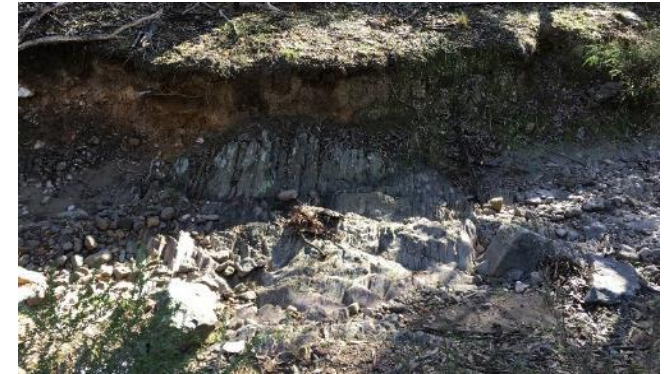
Exposed bedrock is a common feature within the steep headwater streams on the eastern side of the escarpment.

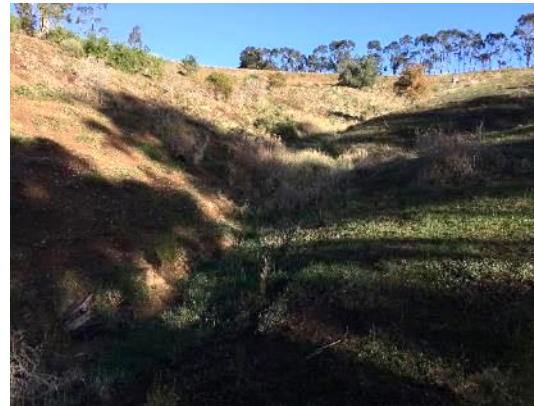
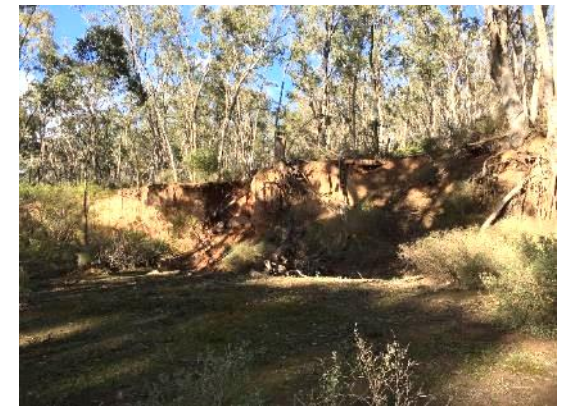
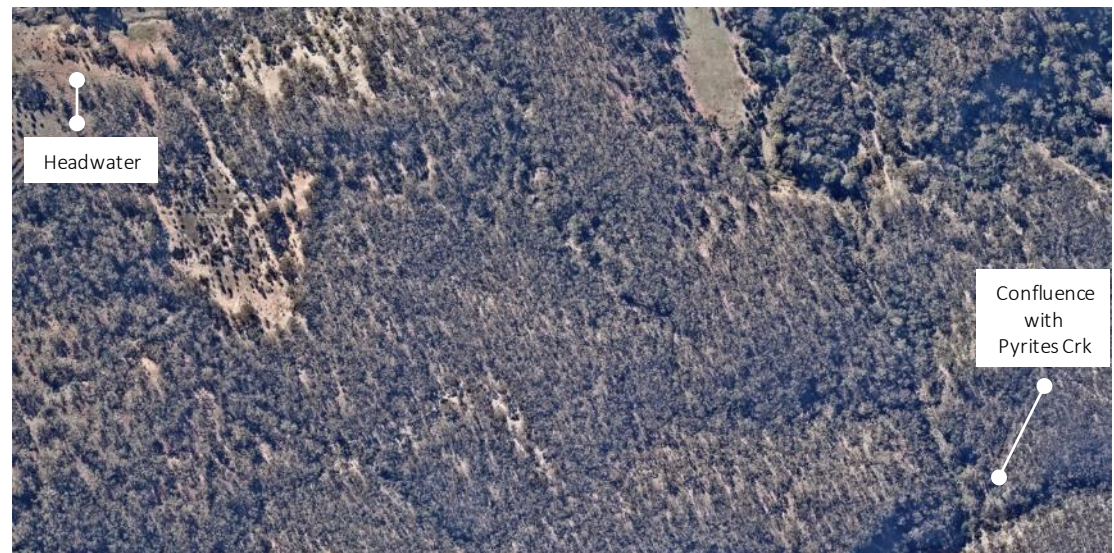
# Steep headwater on mixed sedimentary geology #1

**This waterway is a reasonably well vegetated steep headwater that flows off the eastern side of the escarpment.** The channel is confined by steep valley margins which steepen towards the confluence with Pyrites Creek. Exposed bedrock and large boulders are frequent occurrences along the waterway. Incision and gully development are evident along the waterway, particularly through the mid reaches.

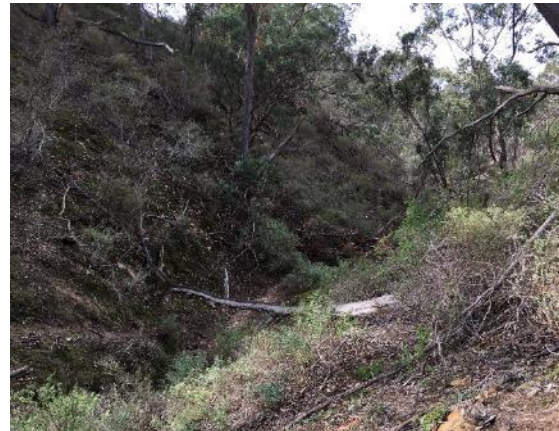
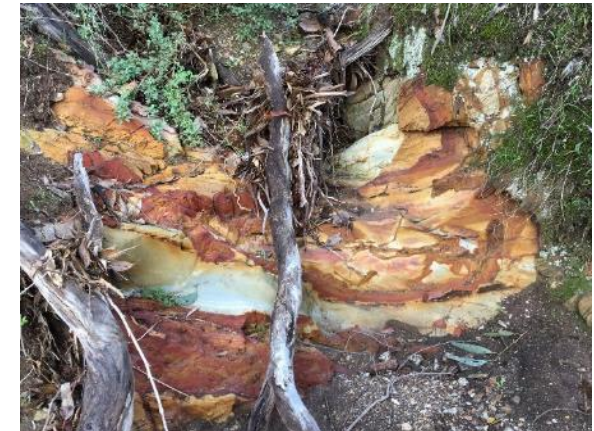
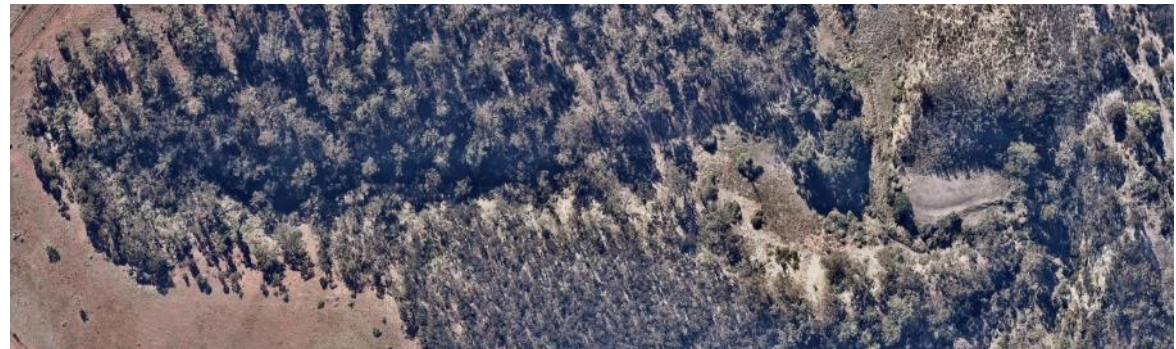
# Steep headwater on mixed sedimentary geology #3

**This waterway is steep headwater that flows off the eastern side of the escarpment.** The upper reach is well vegetated and confined by very steep valley margins. Valley sides become gentler and less well vegetated in a downstream direction. Exposed bedrock is frequently found throughout the reach.

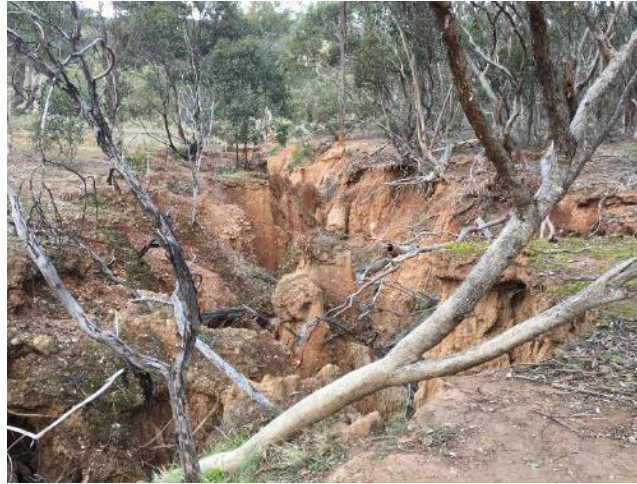
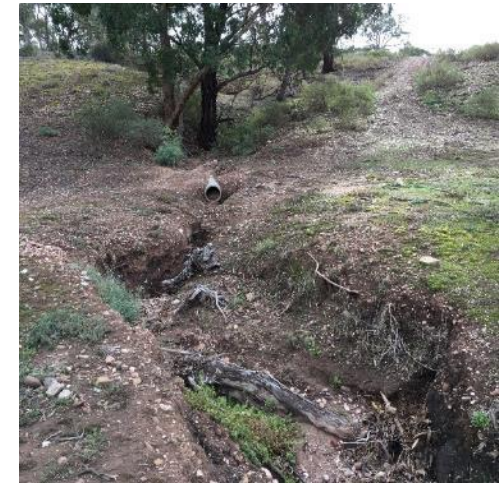
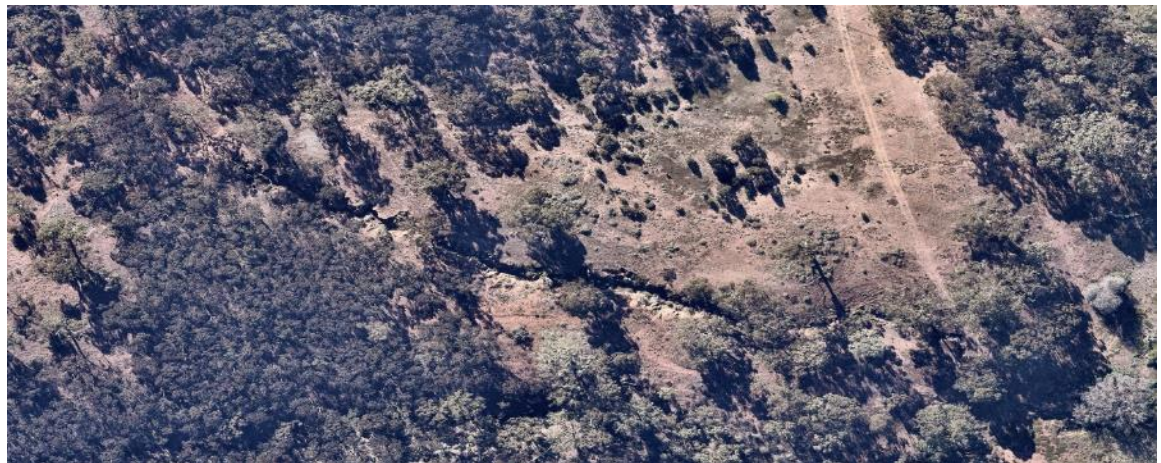
| Parameter | Steep headwater |
|---|---|
| In stream vegetation | Limited instream vegetation. |
| Habitat value | Limited habitat quality |

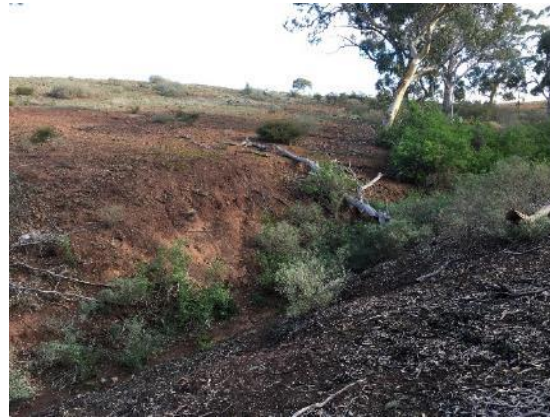
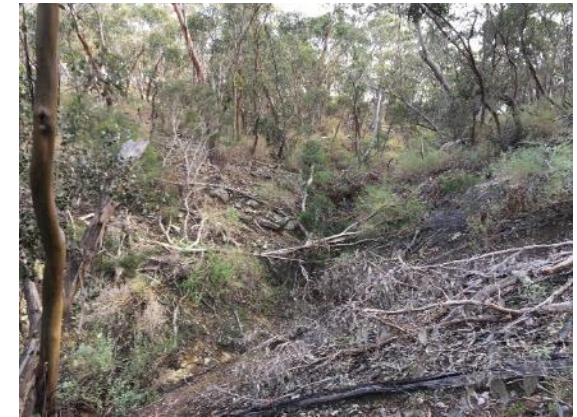
# Steep headwater on mixed sedimentary geology #5

**This waterway is steep headwater that flows off the eastern side of the escarpment.** The upper reach of the waterway is poorly vegetated, however the mid-lower reaches are well vegetated, largely with natives. The waterway is confined within steep valley sides where are steepest through the mid reaches. Exposed bedrock is common along the reach and there is a high load of leaf litter and large wood through the well vegetated zones. Erosion processes in this waterway appear limited to the most upstream extent.

| Parameter | Steep headwater |
|---|---|
| In stream vegetation | Some instream vegetation through the middle reach. Large load of leaf litter and large wood. |
| Habitat value | Moderate quality instream habitats associated with instream grasses, large woody debris, boulders and exposed bedrock. |

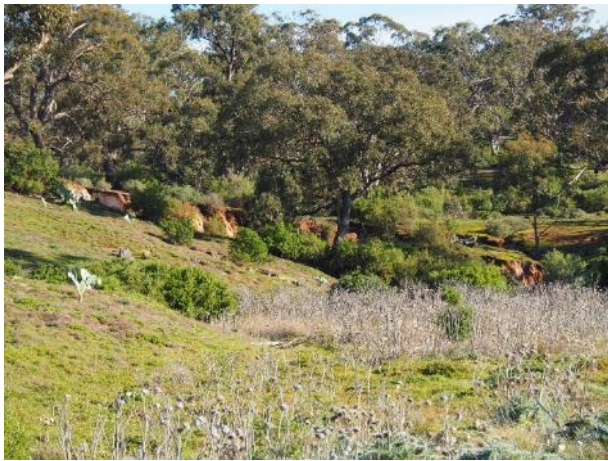
The downstream reach of the waterway is still largely confined by steep valley sides. This reach sits on the more fragile soils of the Werribee Formation and like other sites within the study area significant erosion is evident. Eroded waterway banks display that classic bleached horizon that soils of the Werribee Formation are known for.

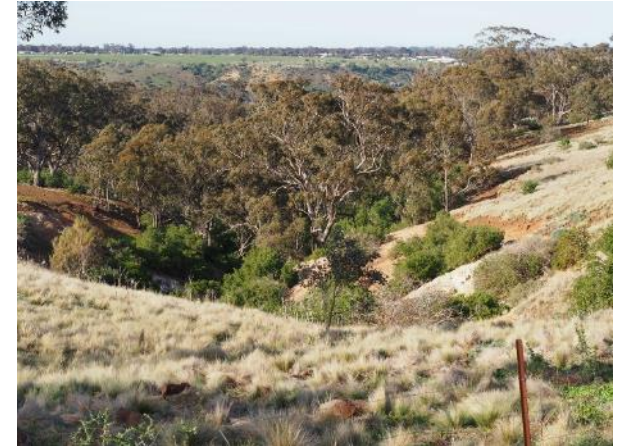
The upper reach of the waterway is very steep as it flows off the escarpment. It is confined by very steep valley sides. At its most upstream extent, the waterway sits on the resistant basalt of the Newer Volcanics. Large basalt boulders are evident in this part of the waterway.

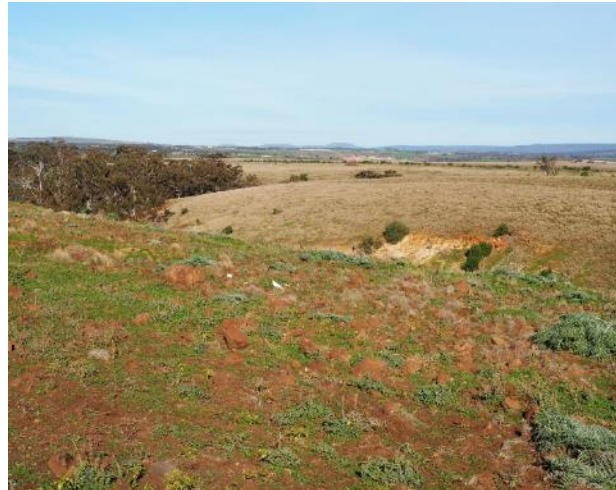
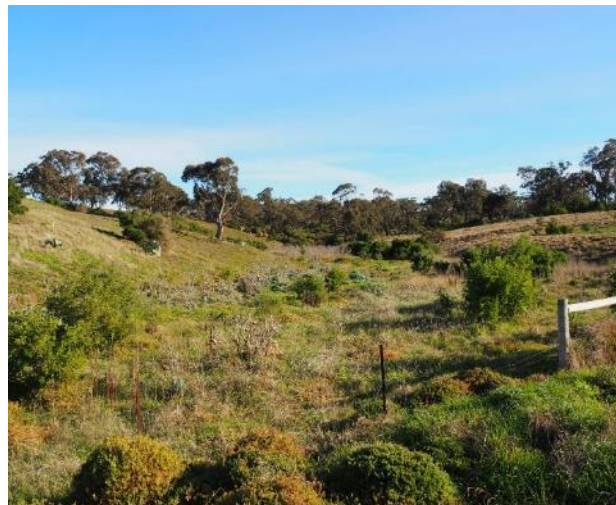
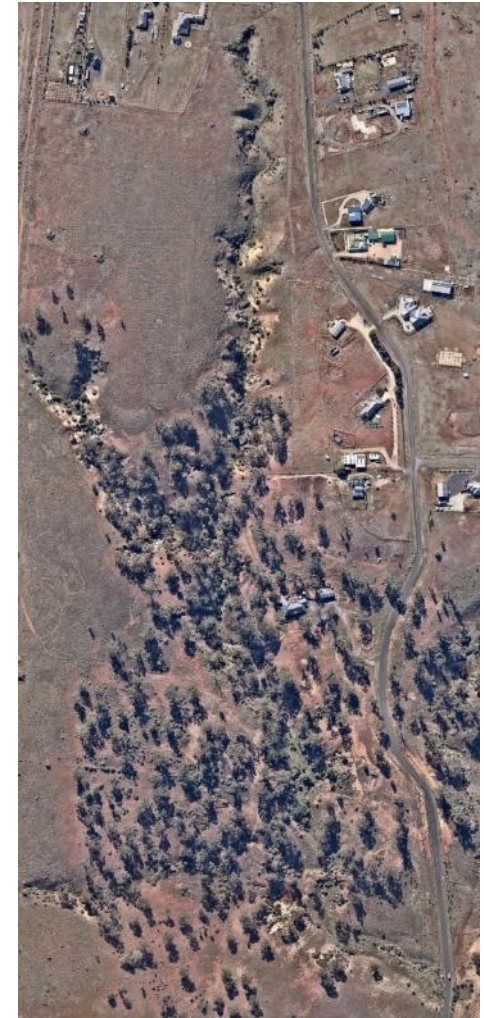
# Steep headwater on mixed geology #1

| Parameter | Steep headwater |
|---|---|
| In stream vegetation | Some instream vegetation observed from the road. Mostly grasses but some shrubs, most likely exotic. |
| Habitat value | Limited instream habitat. |

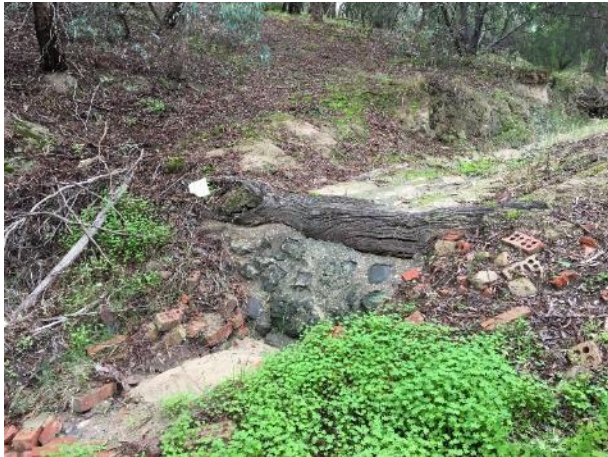
Several old grade control structures are present within the channel running alongside Bacchus Marsh – Gisborne Rd. At various locations along the waterway, the channel passes beneath the road via concrete pipes and culverts.

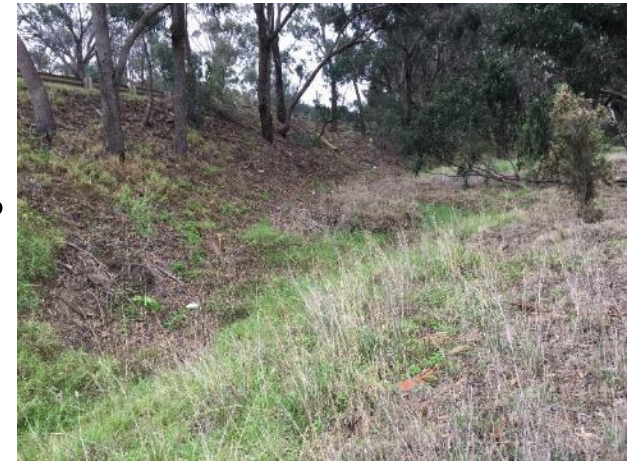
Anthropogenic channels within the study area are a combination of roadside drains and water delivery channels. In some places, drainage lines become indistinct and difficult to follow.

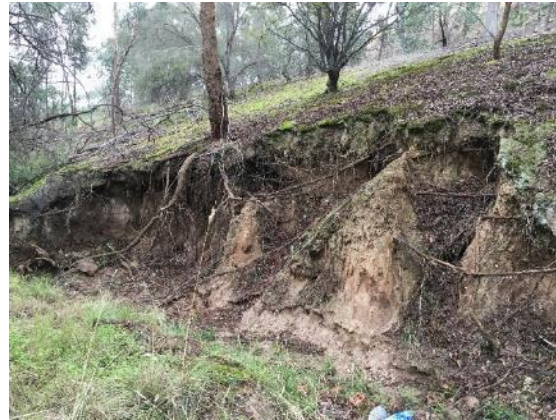
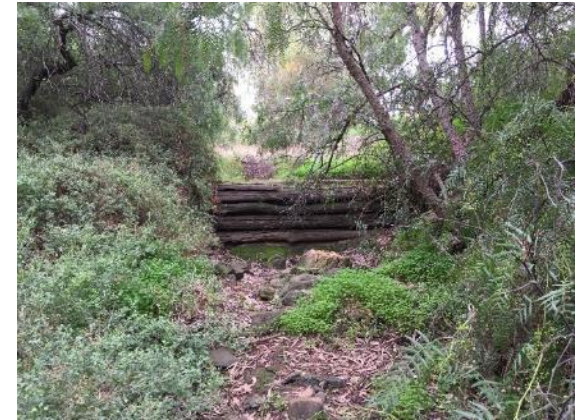
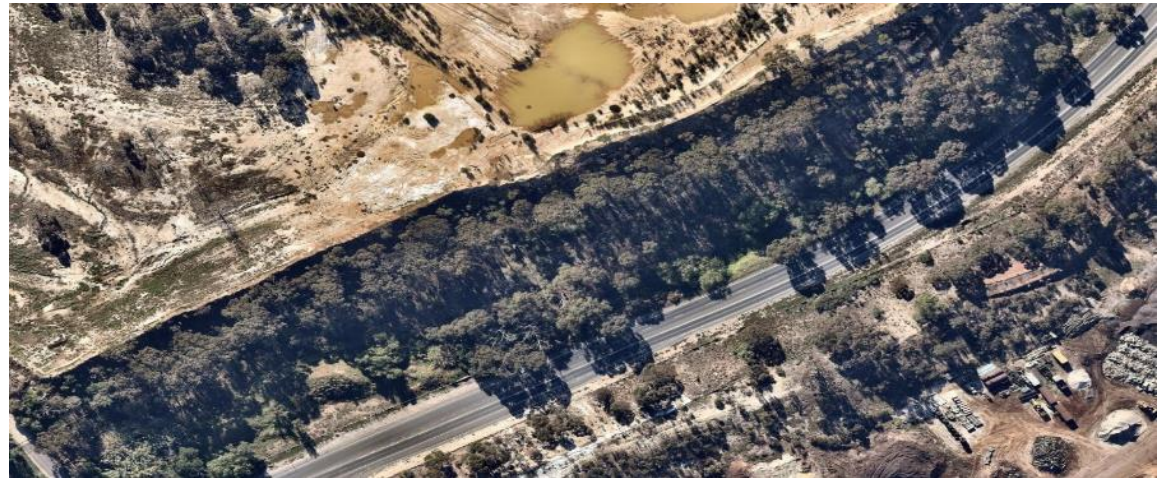
# Anthropogenic channel on mixed sedimentary geology #1

This waterway is an anthropogenic channel that runs alongside Bacchus Marsh-Gisborne Rd. The channel flows alongside the road and crosses it several times through a number of pipes and culverts. There are a number of structures within the channel which appear to be old grade control structures. There is also evidence of erosion in some locations.

| Parameter | Anthropogenic channel |
|---|---|
| In stream vegetation | Some instream vegetation, largely exotic. |
| Habitat value | Limited habitat value. |

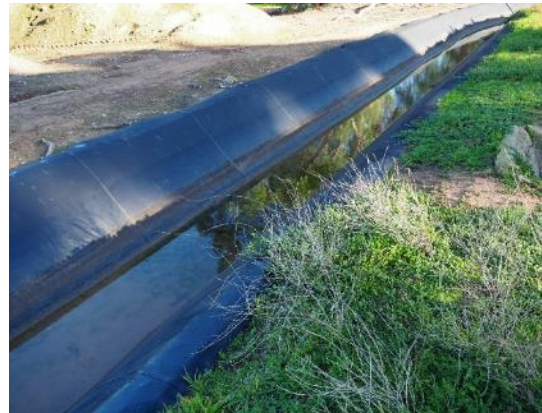
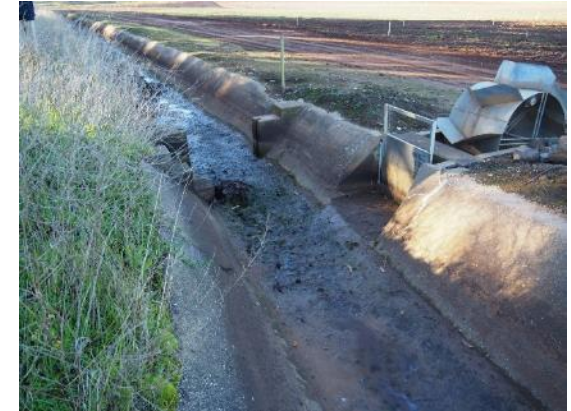
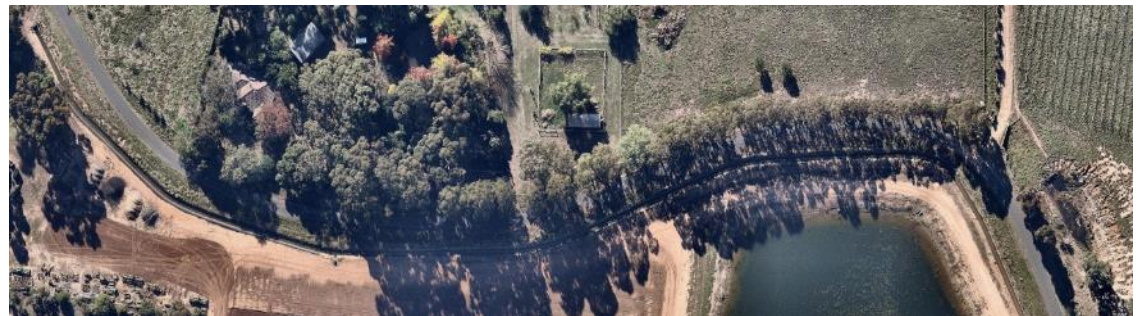
# Anthropogenic channel on mixed sedimentary geology #2

**This waterway is an anthropogenic channel that runs alongside Lerderderg Park Rd.** Despite being mapped as a natural waterway, the field visited revealed that the waterway is actually an active irrigation channel. It appears as though the channel is used to deliver water to market gardens on the floodplain flats. Drainage patterns in this area require further investigation.

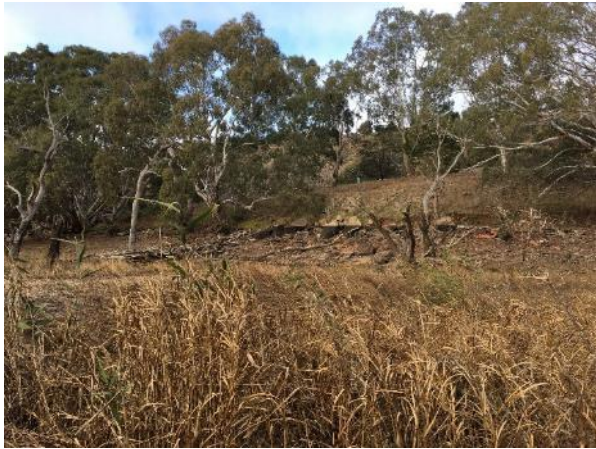
Throughout the reach, former high water marks are evident on trees and rocks. Areas of bank 'notching', common in weirs and reservoirs where water is held at consistent levels, was also evident in some places.

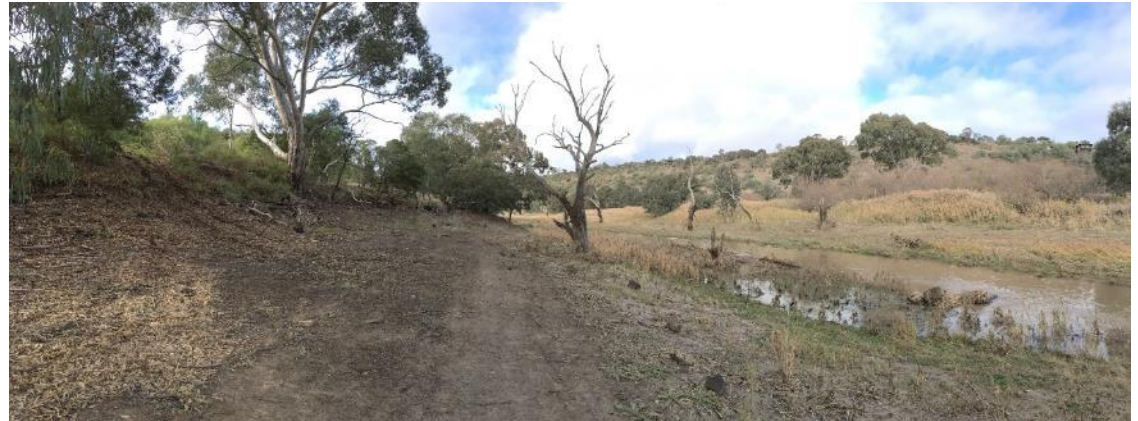
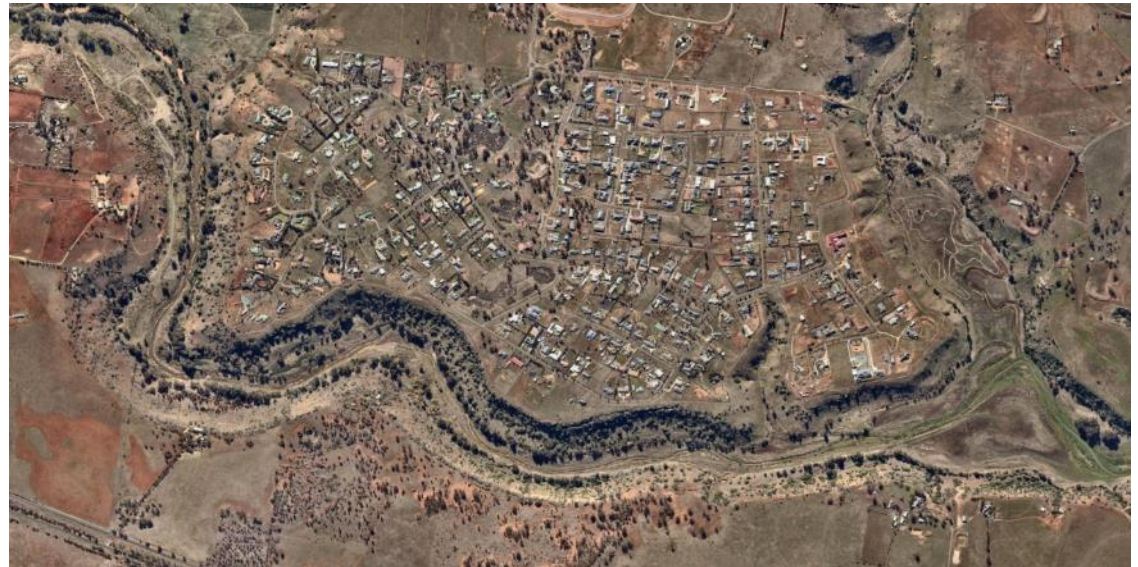
# Werribee River

**This waterway has previously been categorised as a dam or reservoir.** Field observations indicated that this reach of the Werribee River is indeed impacted by backwater effects from Melton Reservoir. Without the effect of the reservoir the reach could best be described as partly confined with floodplain pockets. This reach of the waterway is confined within steep valley sides, although narrow floodplain pockets have developed along either side of the waterway.

| Parameter | Dam or reservoir |
|---|---|
| In stream vegetation | Moderate instream vegetation. Mostly grasses and reeds. |
| Habitat value | Moderate quality instream habitats associated with instream grasses, reeds and pools. |

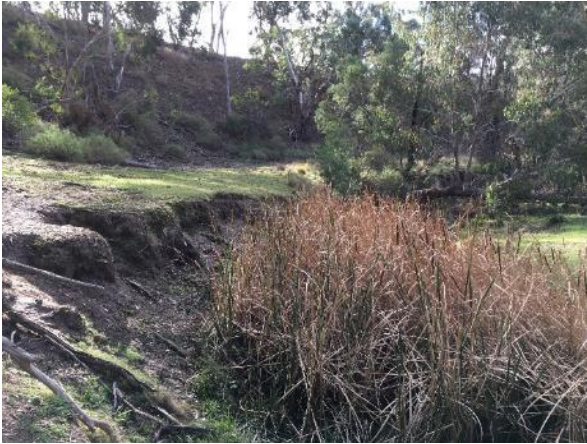
Much of Pyrites Creek is classified as a confined channel with floodplain pockets according to the RiverStyles framework. In these reaches the channel is largely confined by the valley margins, however floodplain pockets are common where the channel becomes only partly confined.

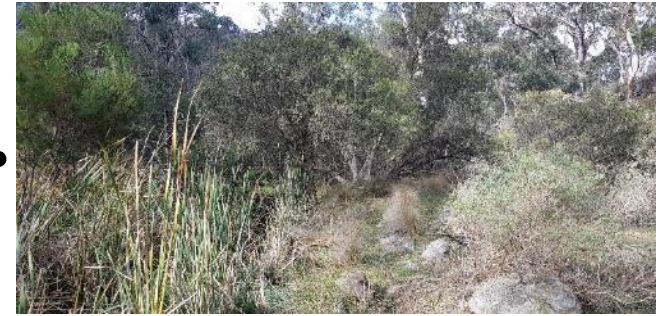
In some reaches, Pyrites Creek has been classified as a gorge according to the RiverStyles framework. Very steep, rock valley sides are characteristic of this reach.

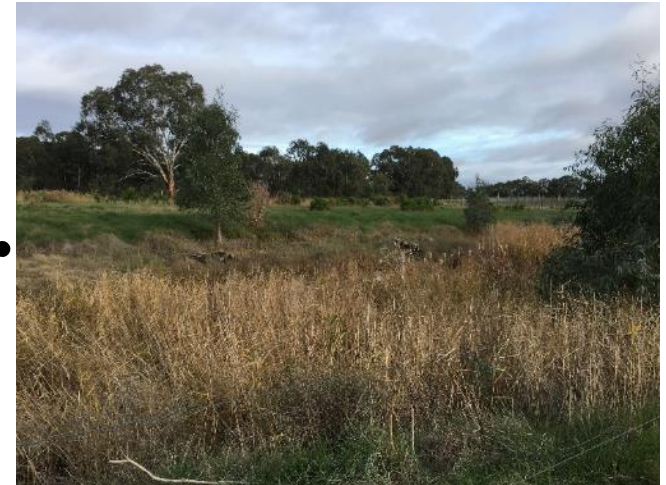
At its confluence with the Werribee River, Pyrites Creek has been classified as an alluvial, continuous, low-moderate sinuosity gravel channel. In this reach that waterway is unconfined and both bed and bank grade are gently sloping.

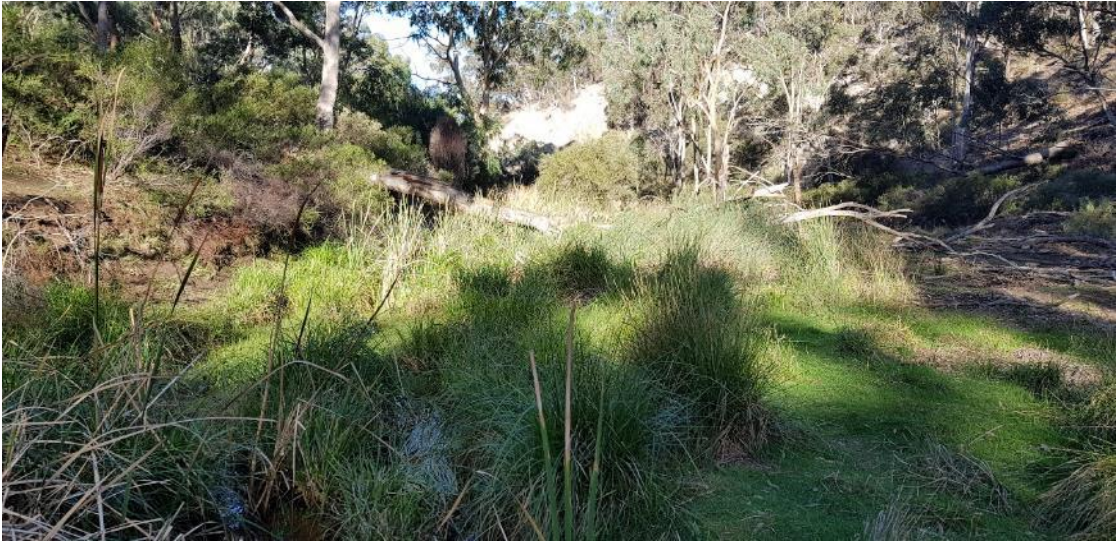
# Pyrites Creek reach 1

**Reach 1 of Pyrites Creek is a partly confined waterway with floodplain pockets.** This reach lies within the Long Forest Nature Conservation Reserve and is very well vegetated. Valley sides are steep, however, channel banks are gently sloping. Occasional pockets of narrow floodplain have developed in places along this reach. There is very little evidence of channel erosion in this reach of Pyrites Creek.

| Parameter | Partly confined floodplain pockets |
|---|---|
| In stream vegetation | Excellent instream vegetation, dominated by native reeds and grasses. |
| Habitat value | Excellent quality habitat associated with well vegetated riparian zone, excellent instream vegetation, large woody debris, pools and riffles. |
