# Merrimu PSP

Final geomorphology and  
vegetation assessment

November 2019

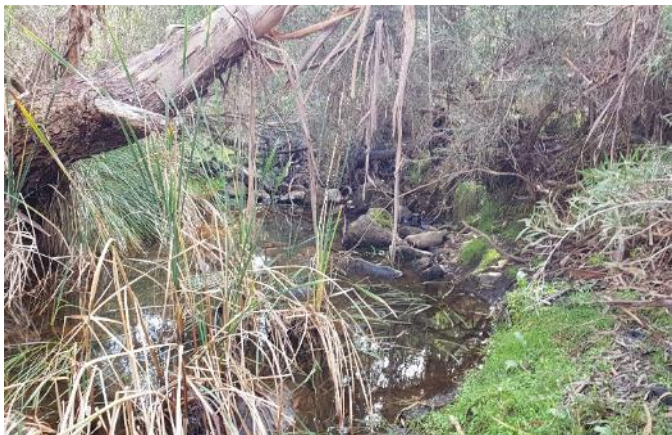
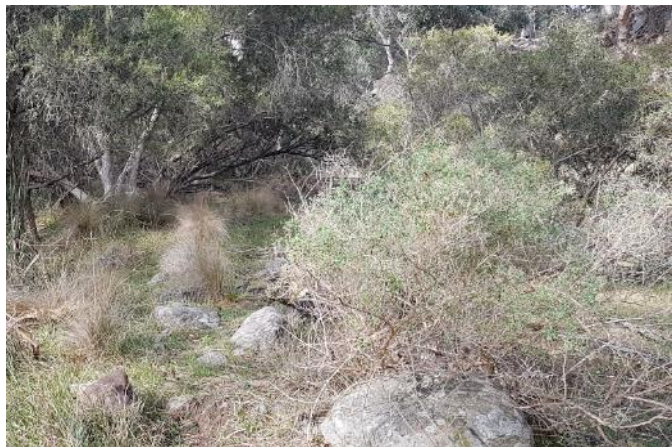
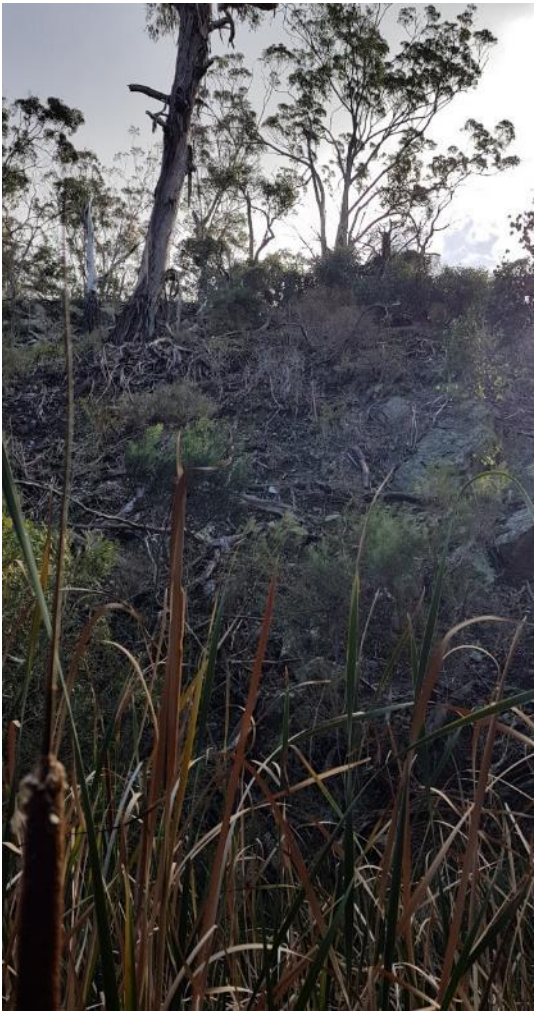
# Pyrites Creek reach 2

**Reach 2 of Pyrites Creek is categorised as a gorge.** This reach lies within the Long Forest Nature Conservation Reserve and is very well vegetated. Valley sides are very steep and comprised of exposed bedrock. Channel bed comprises sand/silt and large boulders are very common throughout the reach. There is limited evidence of erosion along this reach of Pyrites Creek.

| Parameter | Gorge |
|---|---|
| In stream vegetation | Excellent instream vegetation, dominated by native reeds and grasses. |
| Habitat value | Excellent quality habitat associated with well vegetated riparian zone, excellent instream vegetation, large woody debris, exposed bedrock, large bedrock and pools and riffles. |

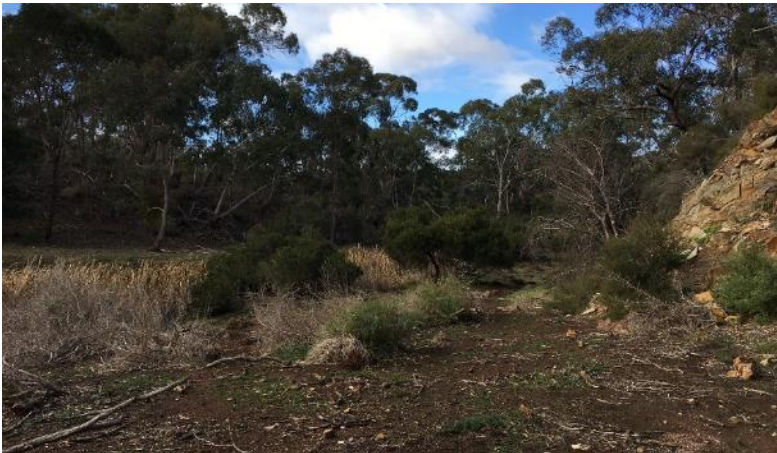
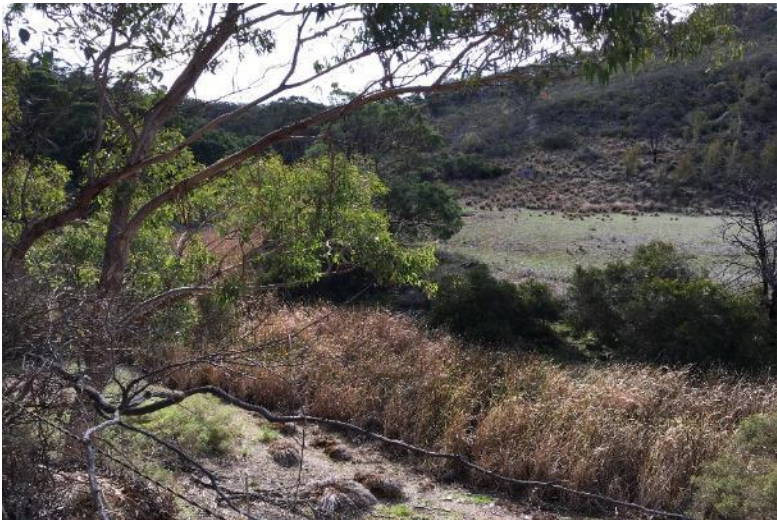
# Pyrites Creek reach 3

**Reach 3 of Pyrites Creek is a partly confined waterway with floodplain pockets.** This reach lies within the Long Forest Nature Conservation Reserve and is moderately well vegetated. Valley sides are steep, however, channel banks are gently sloping. Occasional pockets of floodplain have developed in places along this reach that are more extensive than along reach 1. There is some evidence of channel erosion in this reach of Pyrites Creek.

| Parameter | Partly confined floodplain pockets |
|---|---|
| In stream vegetation | Excellent instream vegetation, dominated by native reeds and grasses. |
| Habitat value | Excellent quality habitat associated with well vegetated riparian zone, excellent instream vegetation, large woody debris, pools and riffles. |

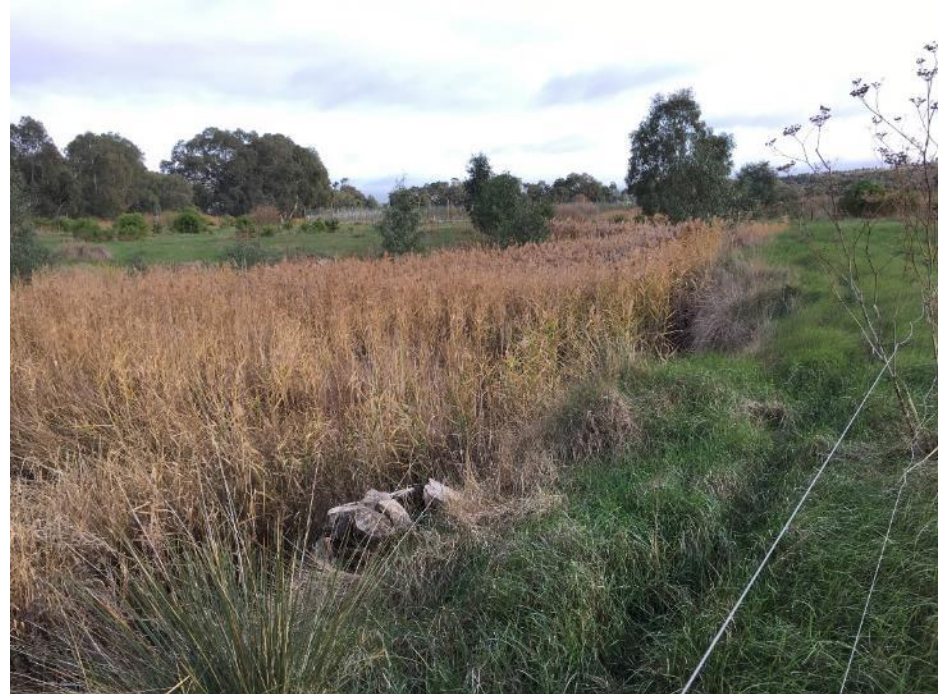
# Pyrites Creek reach 4

**Reach 4 of Pyrites Creek is an alluvial continuous low-moderate sinuosity gravel bed channel.** This reach sits outside the Long Forest Nature Conservation Reserve on the floodplain flats where it joins the Werribee River. The channel is unconfined with gently sloping banks and a relatively flat bed grade. The riparian zone along this reach has been cleared although there are extensive reed beds along the reach, particularly at the confluence with the Werribee River.

| Parameter | Alluvial continuous low-moderate sinuosity gravel |
|---|---|
| In stream vegetation | Some instream vegetation. Largely native reeds. |
| Habitat value | Limited instream habitat associated with reeds. |

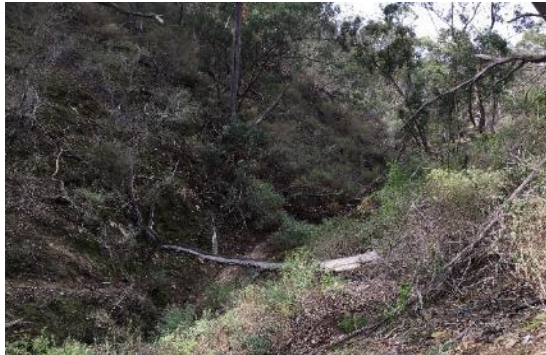
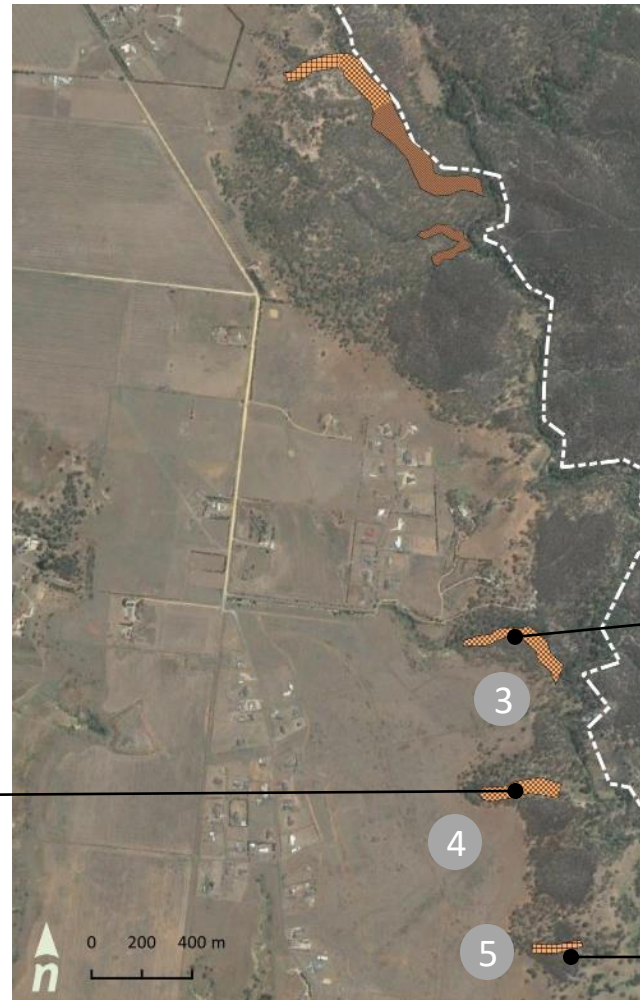
**Low quality examples observed at site 5.** A reduced species rich flora was observed with robust character species remaining. Exotic species such as *Nassella trichotoma* Serrated Tussock and

Remnant vegetation was reduced substantially with robust species such as *Eucalyptus microcarpa* (Grey Box), *Rhagodia parabolica* (Fragrant Saltbush), *Carpobrotus modestus* (Inland Pigface), *Einadia nutans* (Nodding Saltbush), *Enchylaena tomentosa* var. *tomentosa* (Ruby Saltbush)

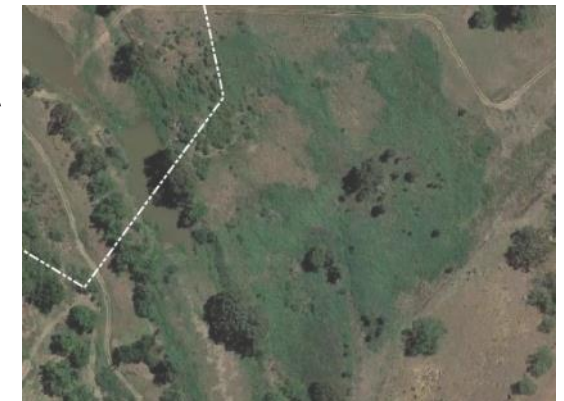
The development of this wetland feature may be a result of water back up from Merrimu Reservoir. The protection of this wetland may warrant consideration in future management decisions.

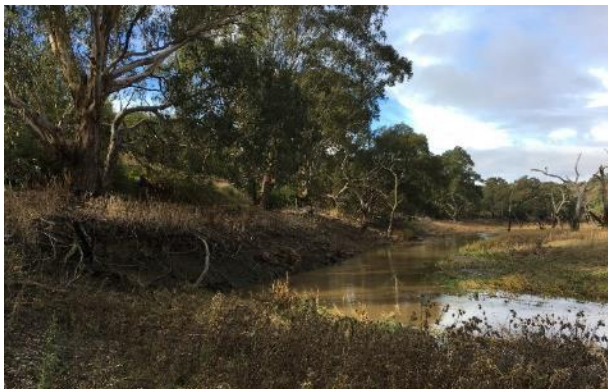
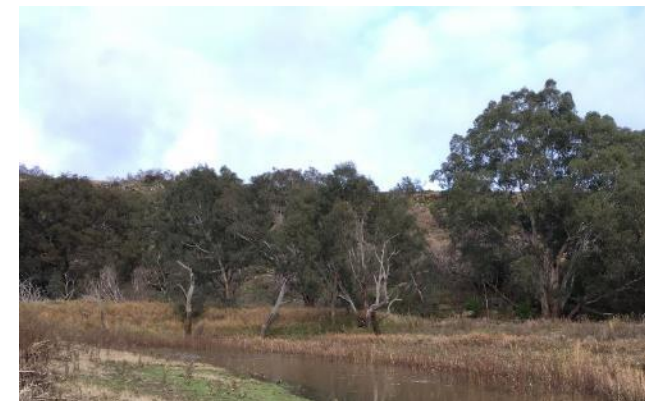
This vegetation community is derived from EVC 68 Creekline Grassy Woodland which is listed as endangered. Observed vegetation no longer contains the range of structural or species elements that would enable it to be categorised as EVC 68.

Prolonged flooding caused by the construction of the Melton Reservoir has resulted in the death of all mature trees. Recruiting trees within this zone are also prevented from establishing due to hydrological fluctuation. Mid storey vegetation has been similarly effected. No mid-storey vegetation remains.

A substantially reduced ground storey diversity remains and has been largely replaced by a range of exotic and indigenous species that are tolerant of prolonged flooding or are able to respond rapidly to receding water levels.

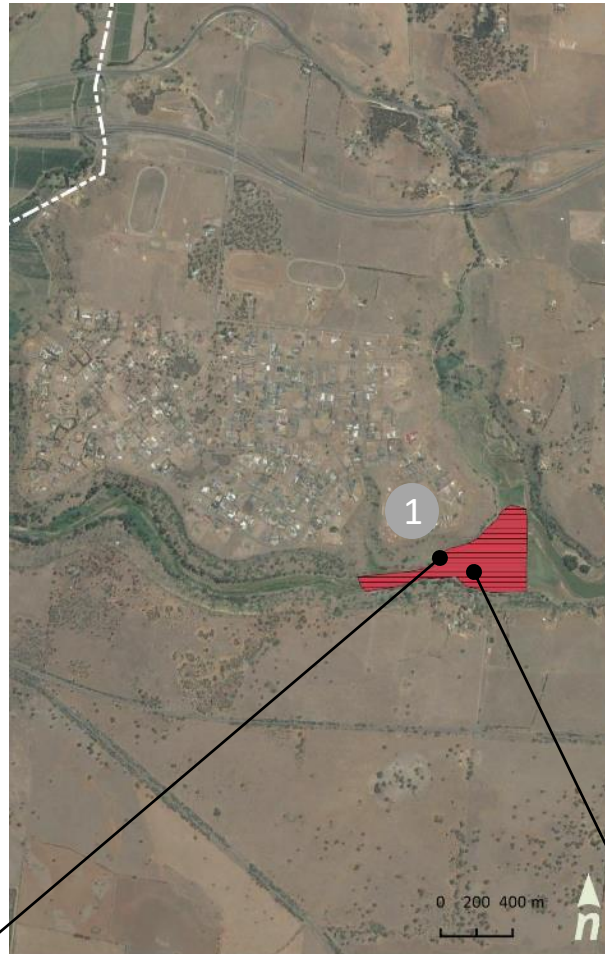
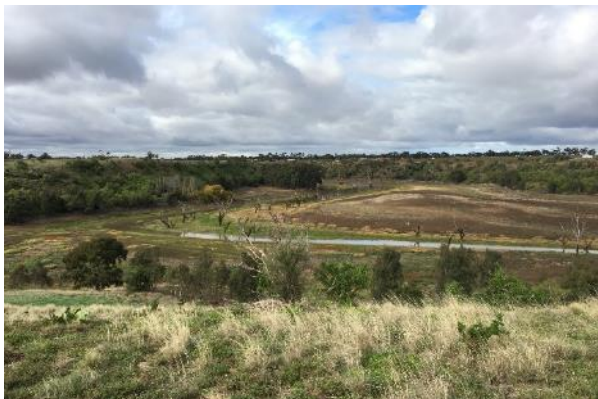
The original herbaceous and graminoid/tussock vegetation structure and composition has been greatly reduced. It now comprises of a much simplified flora. Indigenous species comprise of *Juncus pallidus* Pale Rush, *Juncus sp* Juncus, *Schoenoplectus tabernaemontani* River Club Rush, *Persicaria decipiens* Slender knotweed, *Persicaria lapathifolia* Pale knotweed and *Persicaria prostrata* Creeping Knotweed.

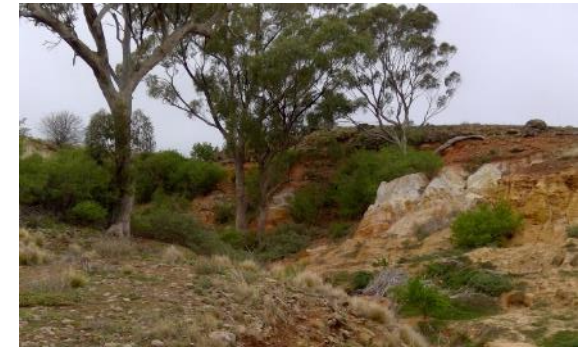
**Sites 1, 2 & 3; low quality vegetation.** Similar structural and species composition; particularly vulnerable to the instability of the substrate on which they occur. Overstorey typically comprises a range of Eucalypt species and a sparse mid storey of *Bursaria spinosa* Sweet Bursaria, *Eremophila desertii* Turkey-bush and *Rhagodia parabolica* Fragrant Saltbush. Ground-storey is limited to robust graminoids such as *Austrostipa scabra* Rough Spear-grass, *Austrodanthonia caespitosa* Common Wallaby-grass,, *Microlaena stipoides var. stipoides* Weeping Grass. *Nassella trichotoma* Serrated Tussock makes up the majority of ground-storey biomass

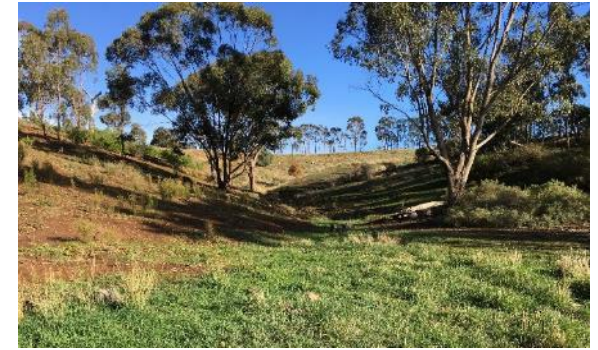
Site 8&9 exemplify the impact of isolation. These patches are subject to degradation from grazing, weed invasion and are highly sensitive to erosion. Note the dominance of exotic grasses (above) and presence of exotic woody weeds (below).

These small patches will continue to decline or at best remain in very poor condition without intervention. Any change in hydrology will further exacerbate their decline particularly at site 9 (below) where extensive erosion is clearly evident and continues to expand laterally.

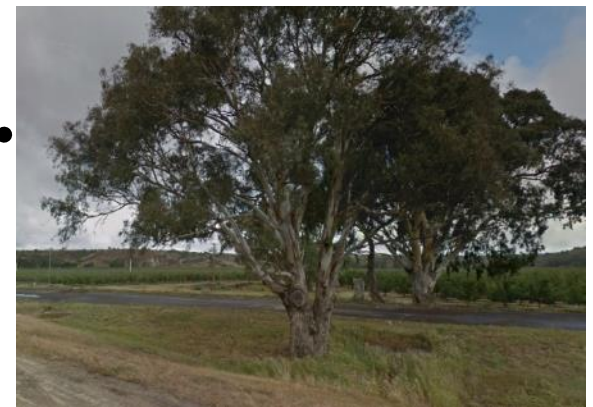
**Sites 1; low quality vegetation.** Overstorey is reduced to a small patch of *Eucalyptus camaldulensis* River Red-gum. Groundstorey vegetation is reduced to *Phragmites australis* Common Reed and *Persicaria decipiens* Slender Knotweed. True aquatics and species tolerant of intermittent to seasonal inundation are absent.

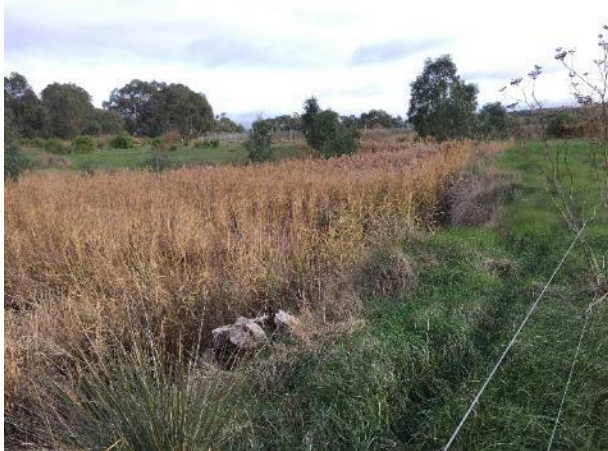
## Sites 2 very low quality; Species observed.

Overstorey is reduced to recently planted *Eucalyptus camaldulensis* River Red-gum. Ground-storey vegetation is reduced to *Carex appressa* Common Sedge, *Persicaria decipiens* Slender Knotweed and *Phragmites australis* Common Reed. True aquatics are absent.

Exotic species dominating this portion of the study are include *Cenchrus clandestinus* Kikuyu, *Cirsium vulgare* Spear Thistle, *Conium maculatum* Hemlock, *Cyperus eragrostis* Drain Sedge, *Foeniculum vulgare* Fennel and *Juncus acutus subsp. acutus* Spiny Rush

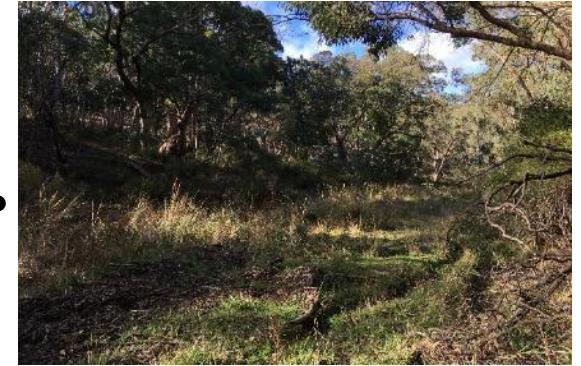
The upstream extent of this vegetation type was well vegetated with *Eucalyptus baueriana* subsp. *thalassina* (Werribee Blue-box) as the dominant overstorey. Instream vegetation was dominated by *Typha domingensis* Narrow-leaf Cumbungi (see above).

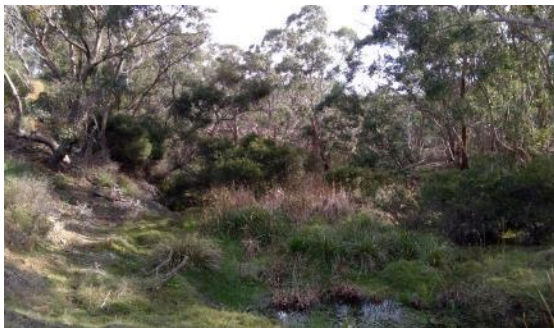
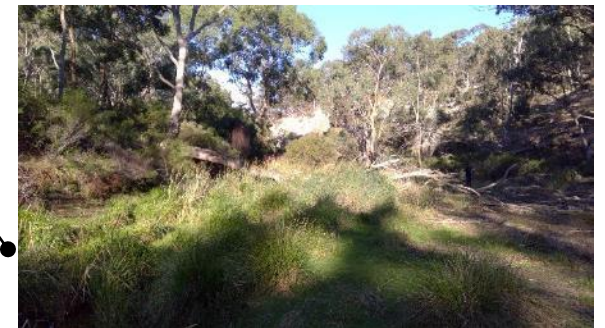
The down stream extent was well vegetated with *Eucalyptus viminalis* (Manna Gum) as the dominant overstorey. Instream vegetation was dominated by *Carex appressa* Tall Sedge, *Carex fascicularis* Tassel Sedge, shrubs such as *Callistemon sieberii* River Bottlebrush were thriving (see a below).

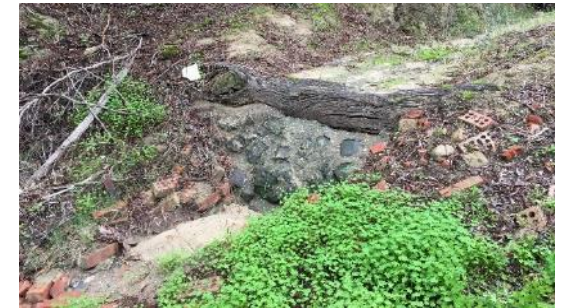
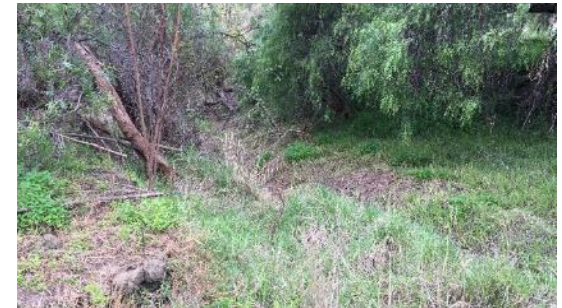
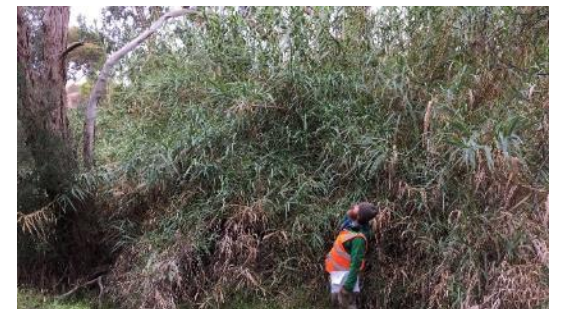
In addition to the diverse range of exotic species this reach also contains areas planted with non-indigenous native species including Eucalypts and Acacias. Isolated patches of high density, high biomass robust exotic species such as *Arundo donax* Giant Reed were observed (image 3). This section has a number of grade control structures (Image 2) to reduce erosion and potentially minimise the effects of sedimentation from the adjoining quarry
