Merrimu Precinct Structure Plan Water Balance and Development Options - Erosion Management | Pre-planning Advice and Risk Assessment Options for Managing Urban Stormwater

September 2021

Ref: P0120217\_Merrimu Precinct Structure Plan Pre-planning Advice and Risk Assessment Options for Managing Urban Stormwater\_R01\_V3a

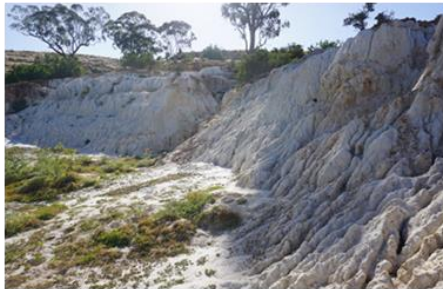
Site characterised by gully erosion which has exposed the underlying Werribee formation (the sodic soil layer). Gully erosion is extensive along this waterway and is ongoing

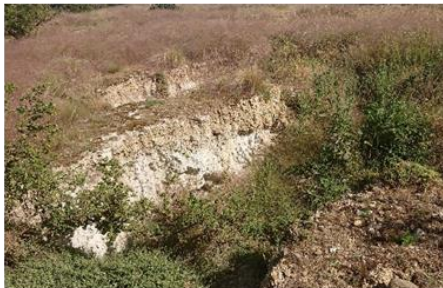
The upstream parts of site two is characterised by a stable waterway with a good coverage of grasses – there are no signs of erosion. The downstream section of this waterway, is characterised by gully formation on the left bank (adjacent the former quarry) and tunnel erosion on the lower portion of the right bank

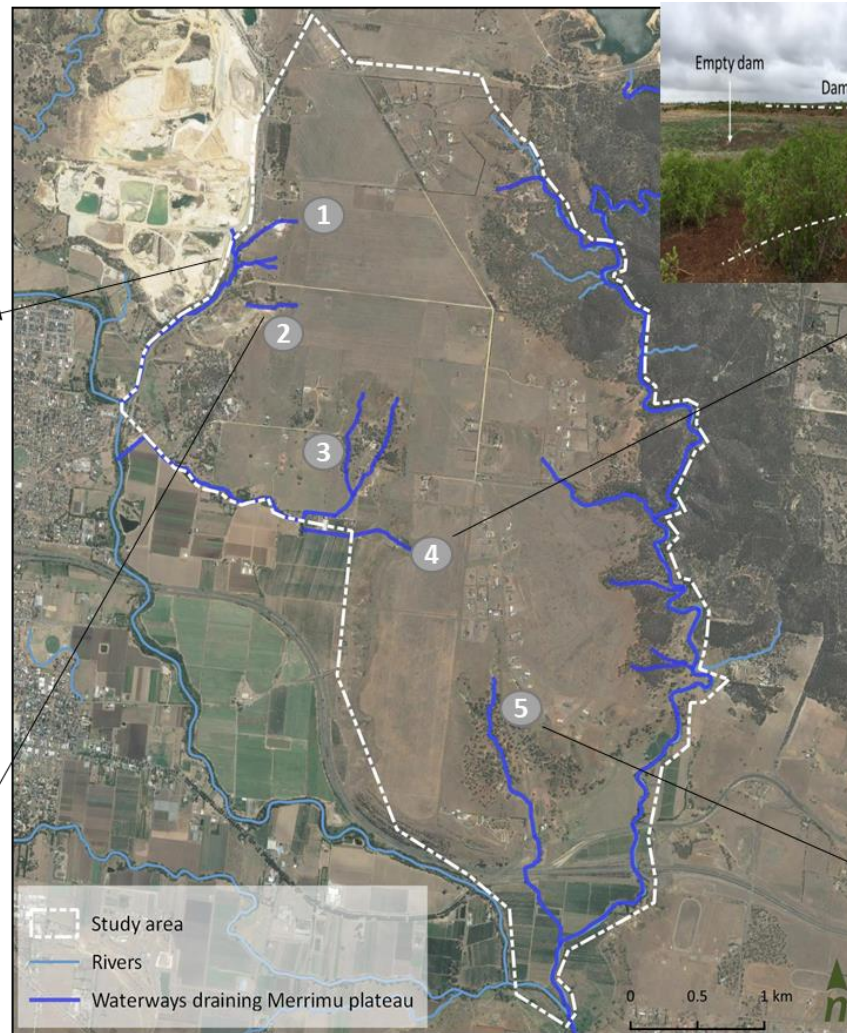
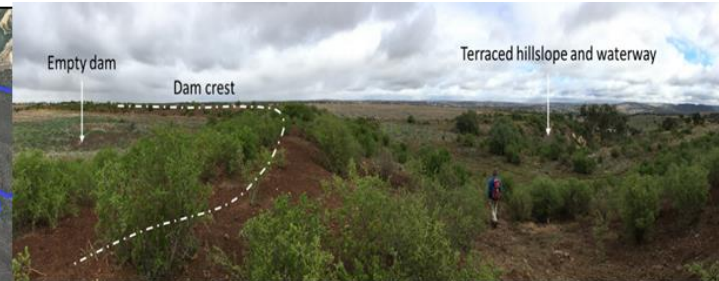
A large farm dam (that was dry at the time on the site visit) rests adjacent, and immediately up-slope from a large, terraced section of waterway. The date or purpose of the terraced works on the waterway is unknown, but is likely to have been completed as part of erosion control measures.

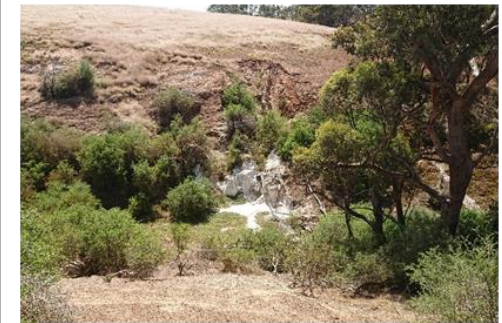
The upstream end of waterways at the south of the plateau are stable and well-vegetated. There were no signs of permanent, standing water in the streambed but localised sections of erosion, which have exposed Werribee formation soils, were visible in the downstream section.

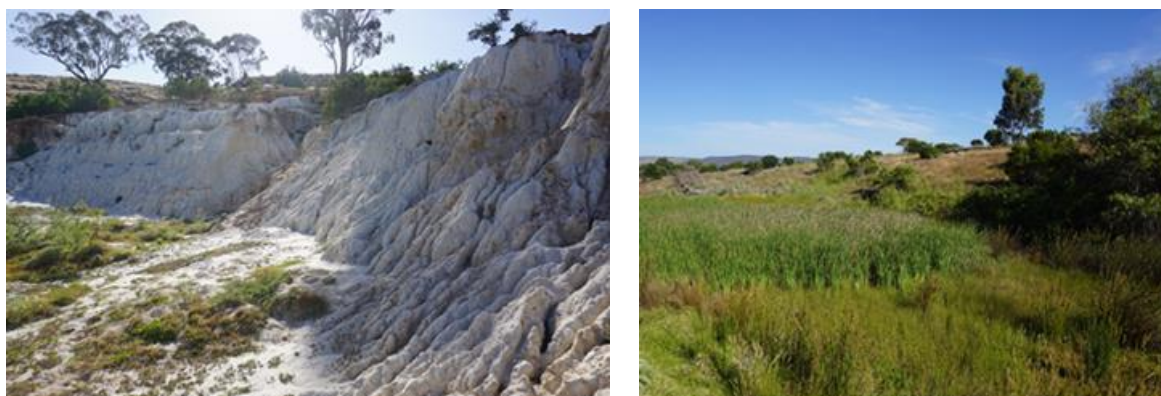
**Figure 10.** Exposed Werribee Formation soils that have eroded to form gullies (left), a small localised wetland immediately below the eroding gullies (right).

Site one is characterised by gully erosion which has exposed the underlying Werribee formation (the sodic soil layer). Gully erosion is extensive along this waterway and is ongoing (Figure 10). A small wetland has formed in the base of the waterway that the gullies feed, with the dense vegetation indicating that this depressions is permanently saturated.

The location of the wetland at site one may be due to localised groundwater patterns, where the water table intersects the surface and feeds the wetland. Alternatively, the wetland may have formed in a depression with low permeability soils that collects surface flows that are then unable to infiltrate into the ground below (i.e. the wetland is not the result of an elevated water table). While the exact mechanism controlling leading to the wetland is unknown, its location within the waterway, and the fact that similar wetlands *were* not observed at any other of the waterways along the plateau margin, suggests that this is a localised feature, rather than evidence for an elevated water table that extends across the plateau.

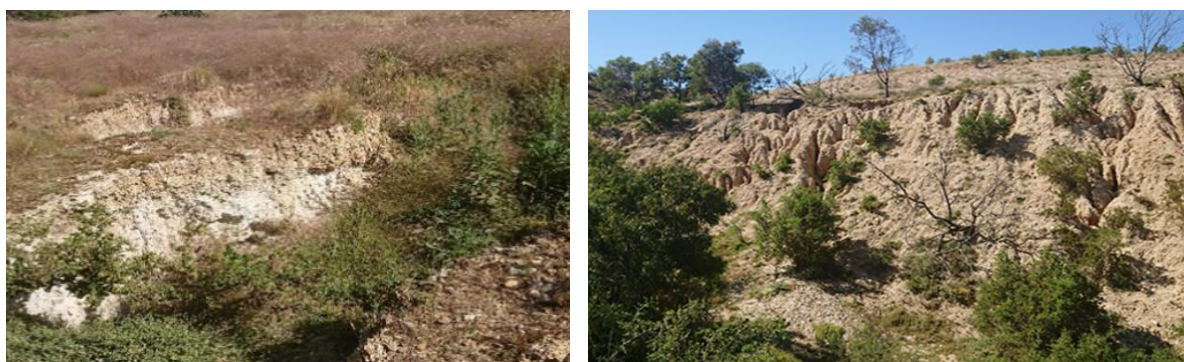
**Figure 11** Tunnel erosion on the northern side of the drainage line at the base of the slope, immediately beside the waterway (left), looking downstream and across the waterway at the eroding cliffs on the southern side – beside the former quarry (right).

The upstream parts of site two is characterised by a stable waterway with a good coverage of grasses – there are no signs of erosion. However, in the downstream section of this waterway, is characterised by gully formation on the left bank (adjacent the former quarry) and trunnel erosion on the lower portion of the right bank (Figure 11). The key insights from this site are that tunnel erosion is promoted adjacent eroding (and more incised) waterways, where the local groundwater gradient is very steep. We found no evidence for tunnel erosion on the surface further upstream or at higher elevations on the right bank. The erosion on the left bank is due to the unconsolidated nature of the soils, which were likely material excavated from the quarry that was then tipped into the adjacent gully.

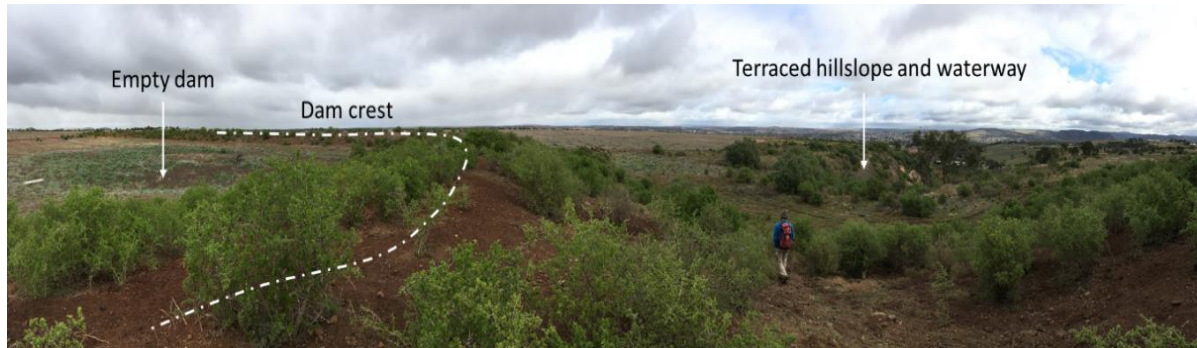
**Figure 12.** Looking south at the edge of the plateau, showing the proximity between a (currently empty) farm dam on the left of the photo and a terraced hillslope, likely to control past erosion issues, on the right of the photo.

A large farm dam (that was dry at the time on the site visit) rests adjacent, and immediately up-slope from a large, terraced section of waterway (Figure 12). The date or purpose of the terraced works on the waterway is unknown, but is likely to have been completed as part of erosion control measures. We speculate that water infiltrating through the dam may have contributed, via tunnel erosion and collapse, to erosion at the head of the adjacent waterway.

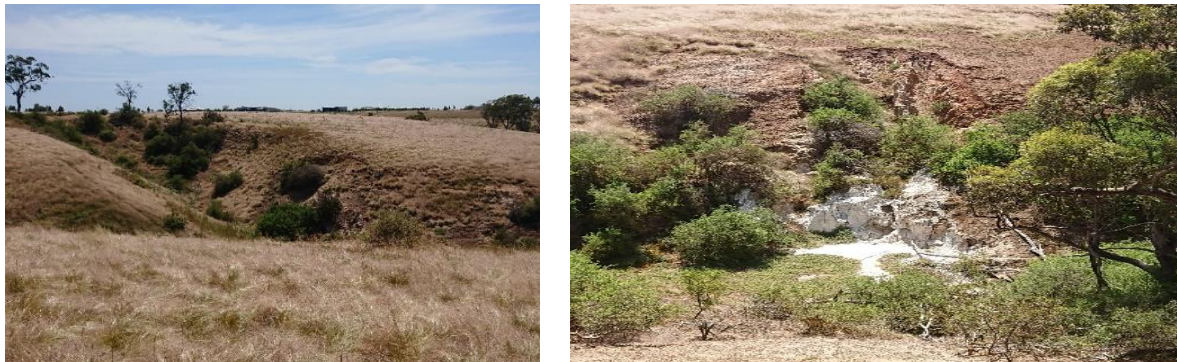
**Figure 13.** The upstream extent of the waterways which is stable and has no signs of erosion – sodic soils are not present (left), a localised section of erosion that has exposed sodic soils at the base of the gully, downstream from the photo (right).

The upstream end of waterways at the south of the plateau are stable and well-vegetated. There were no signs of permanent, standing water in the streambed but localised sections of erosion, which have exposed Werribee formation soils, were visible in the downstream section. The key insight from this site is that under current conditions the waterway is stable and not incising, but that the waterway is highly sensitive. Once erosion scours the cap of basalt soils to expose the underlying Werribee formation soils, gully erosion initiates and migrate up-slope (Figure 13).

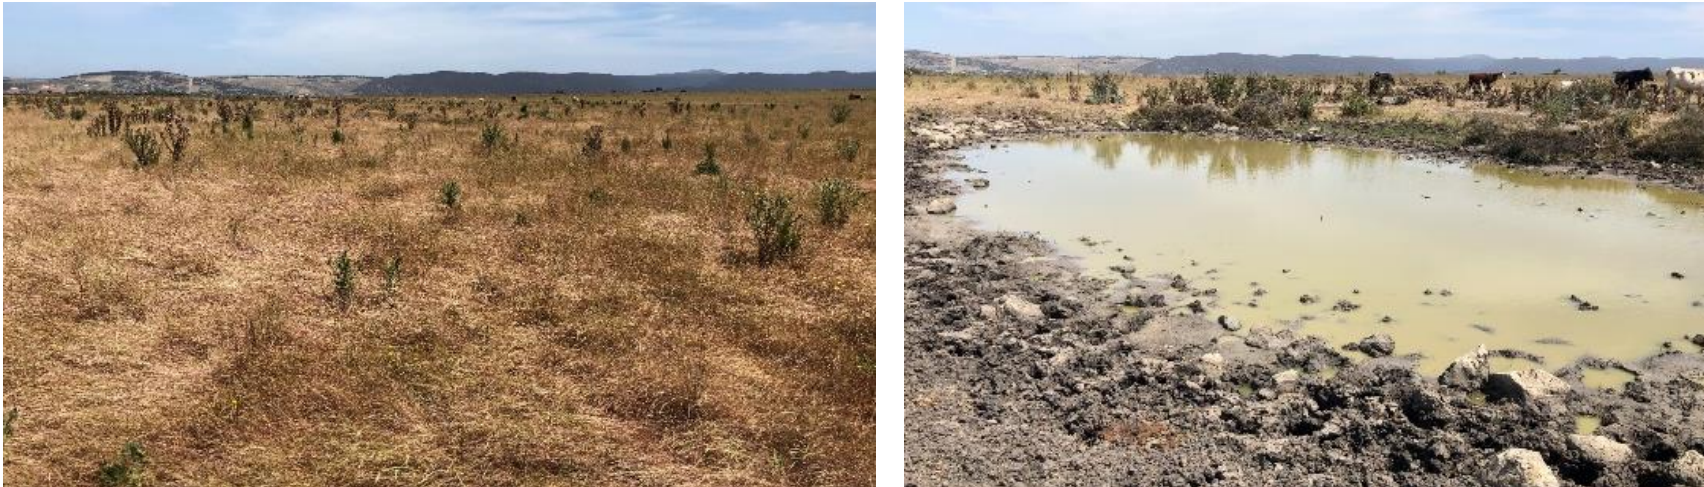
**Figure 14.** Typical cover of exotic vegetation in Wetland A – image taken facing west (left), degraded dam at the west edge of the natural wetland area of Wetland A (right).

This site is approximately 5.69 hectares in area. The site is a treeless grassy area dominated by exotic species at the time of assessment. Review of aerial imagery indicates that Wetland A has a history of cropping/pasture renovation and is currently grazed. Two constructed dams occur at the west end of the natural wetland depression. These are highly degraded and are not considered part of the natural wetland feature. The site may express vegetation characteristics consistent with Seasonal Herbaceous Wetland in wet years. Landscape characteristics and location are consistent with this vegetation type. State-wide flora mapping indicates the eastern edge of the site is mapped as Plains Grassland.

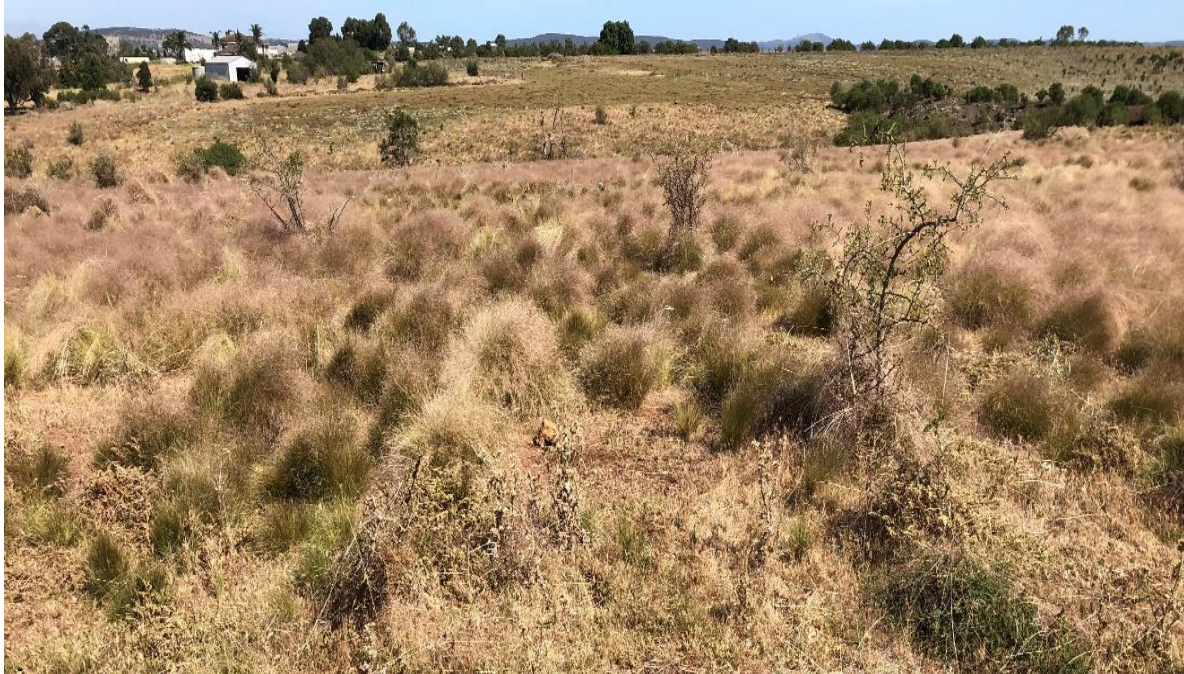
This site is approximately 0.9 hectares in area. The site is a treeless grassy area and is almost entirely dominated by Serrated Tussock. A wetland is not present, and it is assumed that this is a mapping/modelling anomaly has incorrectly designated this as a wetland. Review of aerial imagery indicates that it has been heavily grazed or has had a range of weed management activities take place. No indigenous species were identified in the subject area.

**Figure 15** Note the high abundance of *Nassella trichotoma*

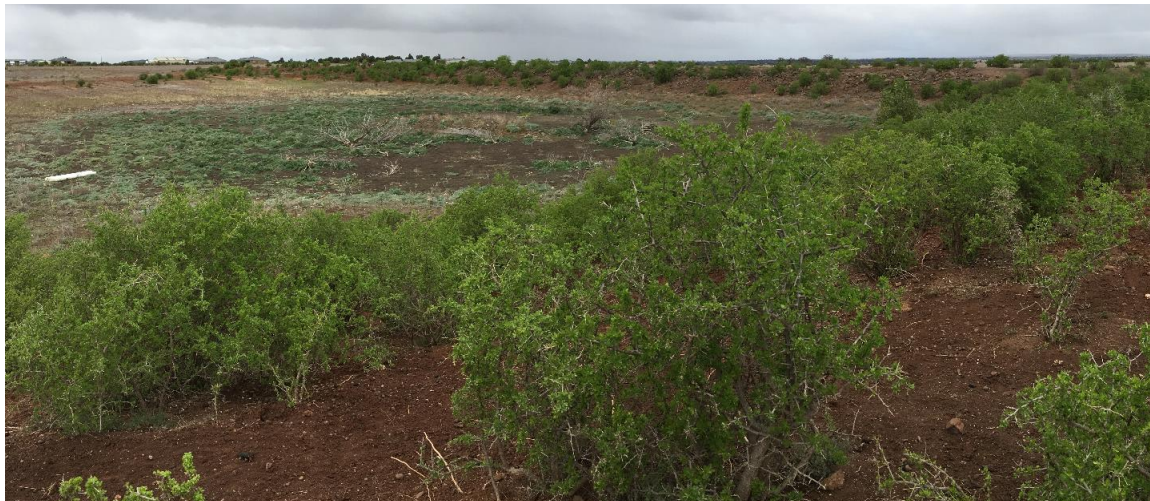
**Figure 16.** Typical overview of degraded dam site, note Boxthorn and Artichoke thistle dominance

This site is approximately 1.6 hectares in area. It is not a natural wetland, our assessment sought to confirm if any indigenous species were present. The site has excavated edges, a clear dam wall and spoil mounds as well as a range of pipes and hoses suggesting that it formed a more permanent water body at some stage in the past. The site is a treeless grassy area with Boxthorn and Briar Rose over an exotic ground-storey dominated by grasses such as Serrated Tussock and exotic herbaceous species including a range of thistle species. The site is within 50 meters of the escarpment and as such would be an inappropriate site for any wetland remediation or stormwater treatment. Further analysis and description of the hydrological issues associated with water management this close to the escarpment is provided in later sections of this document.

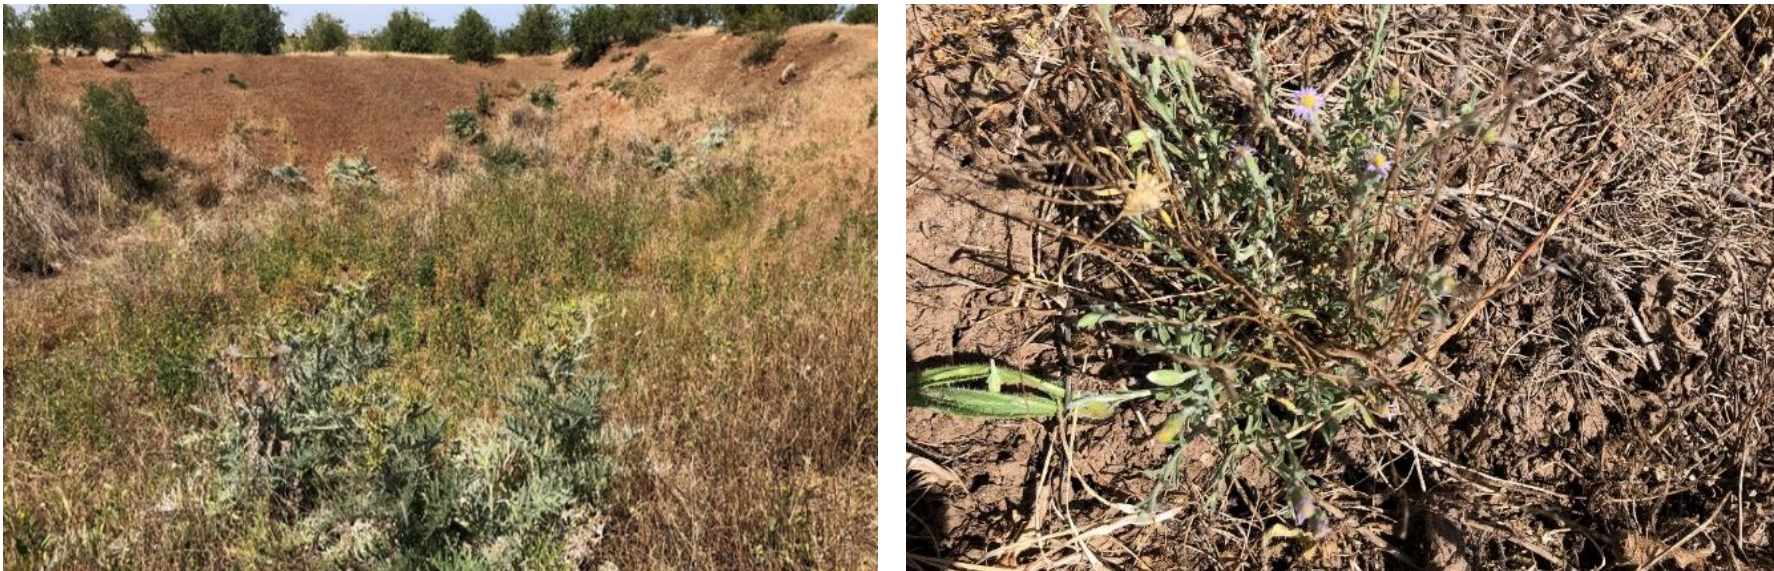
This site is approximately 0.2 hectares in area. Summary. It is not a natural wetland although modelling suggested it may hence our assessment to confirm features and vegetation values. The site has very steep excavated edges and spoil mounds. The site is a treeless grassy area with Boxthorn and Briar Rose over an exotic ground-storey dominated by grasses such as Serrated Tussock and exotic herbaceous species including a range of thistle species. Note that this site is an appropriate site for the future location of any potential stormwater wetland treatment infrastructure given its poor ecological values and low risk location with regard to hydrogeology. This location is a suitable candidate for a range of treatment scenario combinations.

**Figure 17** Typical vegetation composition of the excavated dam (left, the native species *Vittadinia aracilis* was observed (right)

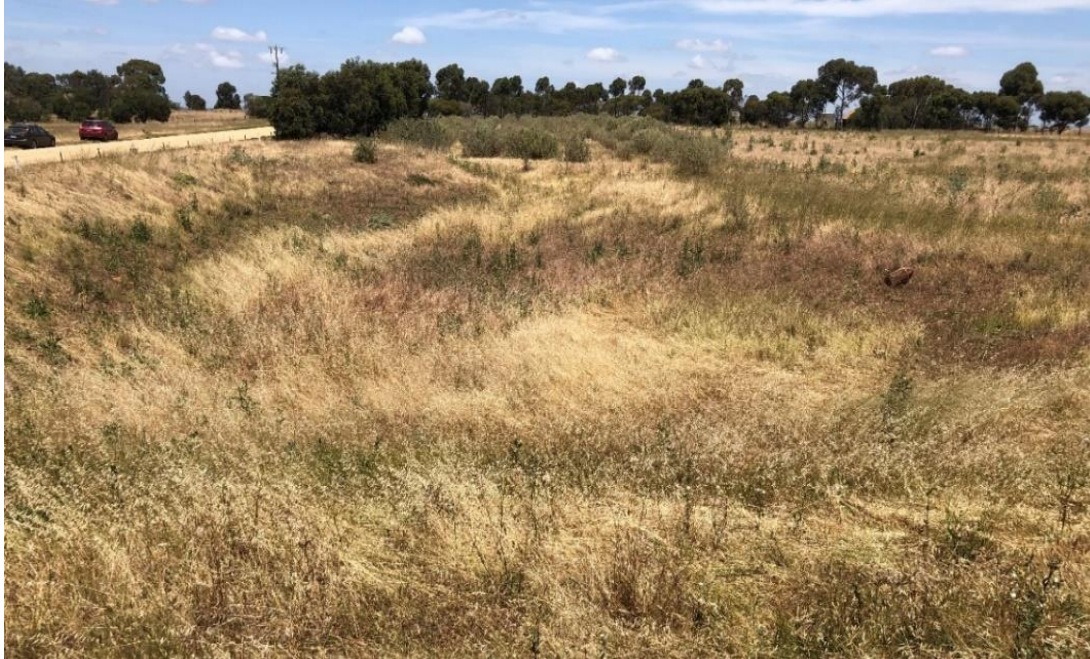
This site is approximately 0.9 hectares in area. As with many other sites it is not a natural wetland although modelling suggested it may hence our assessment. The site has excavated edges and functions as a temporary storage dam. The site is a treeless grassy area with Olives and planted Eucalypts nearby over an predominantly exotic ground-storey. Note that this site is an appropriate site for the future location of any potential stormwater wetland treatment infrastructure given its poor ecological values and low risk location with regard to hydrogeology. This location is a suitable candidate for a range of treatment scenario combinations.

**Figure 18** *Note the relative abundance of woody weeds and a mixture of native and exotic grass.*

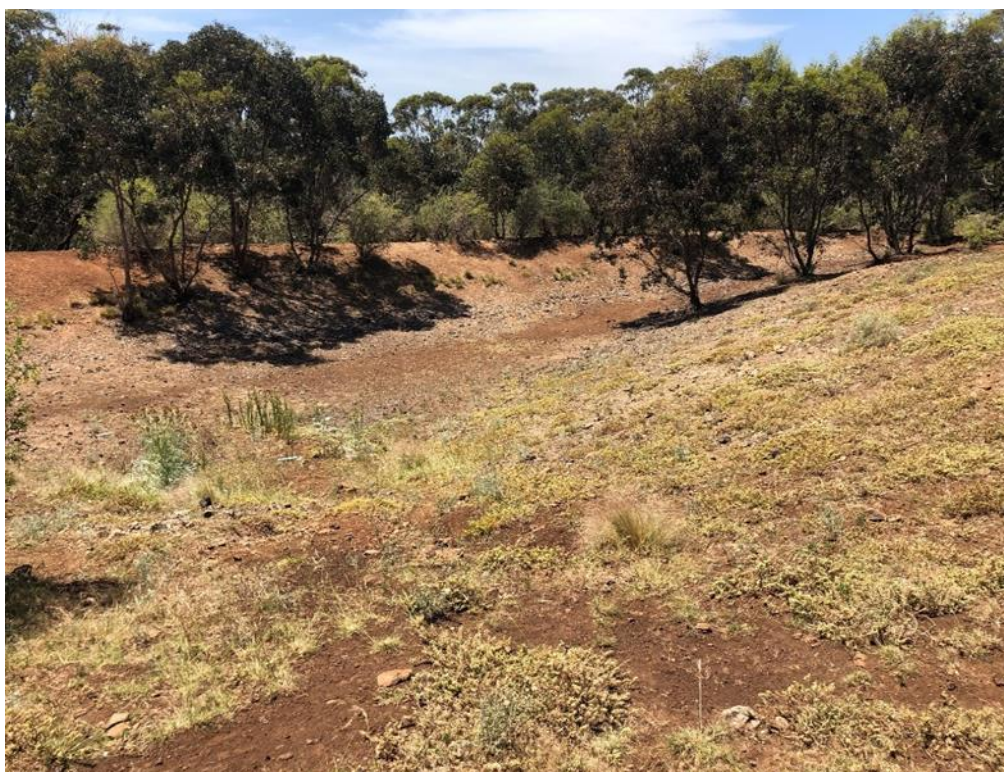
This site is approximately 0.6 hectares in area. This site is an excavated dam, it is not a natural wetland. It is at the edge of remnant woodland habitat dominated by indigenous species however this constructed dam does not have wetland vegetation or native terrestrial species. The site is within 50 meters of the escarpment and as such would be an inappropriate site for any wetland remediation or stormwater treatment. Further analysis and description of the hydrological issues associated with water management this close to the escarpment is provided in later sections of this document.

**Figure 19** Note the proximity to areas of native vegetation and regeneration of Eucalypts.
