## INTERIM REPORT

# Environmental and Geomorphology assessments for selected stormwater outfalls in the Merrimu PSP area

Prepared for  
**Melbourne Water**  
May 2026

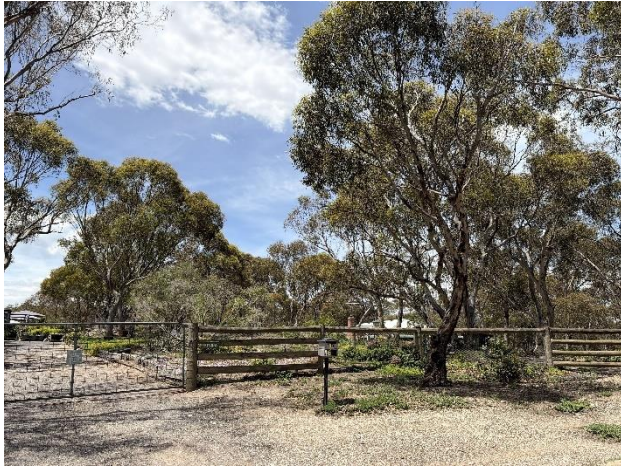
Photo-point 1 is at the northern end of McKenzie Court and shows native and planted exotic vegetation within the private properties. It was unclear if the native vegetation was planted by the property owner or remnant.

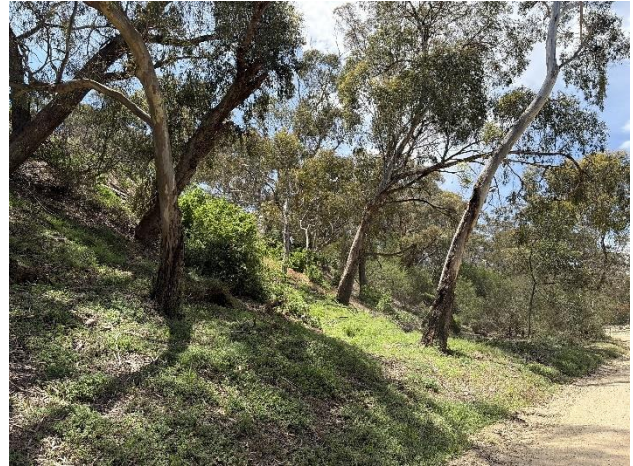
Photo-point 2 shows planted roadside vegetation on the western side of O'Connell Road. There was evidence of planting and weed control, indicating that this area is currently being actively managed.

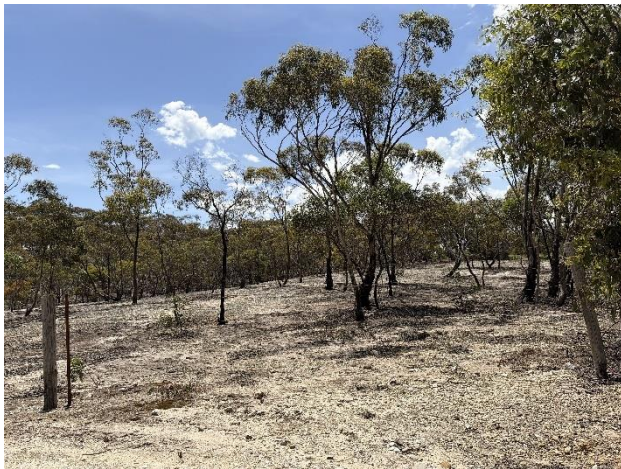
Photo-point 3 shows some sparse native vegetation within one of the private properties north of O'Connell Road, approximately near the centre of the study site.

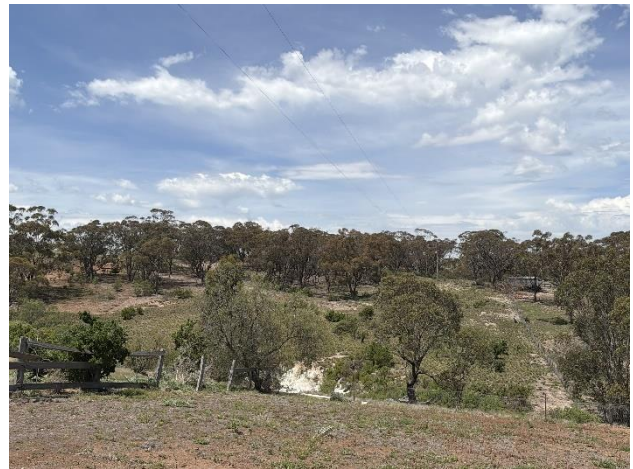
Photo-point 4 shows the patches of native vegetation on the private properties at the eastern end of O'Connell Road, looking towards Bences Road. This appears to be remnant native vegetation, as some of the trees are relatively large, especially in the background of the image. There is a 2009 record of the FFG Act-listed Speckled Warbler (*Pyrrholaemus sagittatus*) within the patch.

- If works proceed within the O'Connell Road study area, a detailed flora and fauna assessment should be undertaken to confirm the extent, condition, and significance of remnant native vegetation and fauna habitat identified during the roadside surveys.

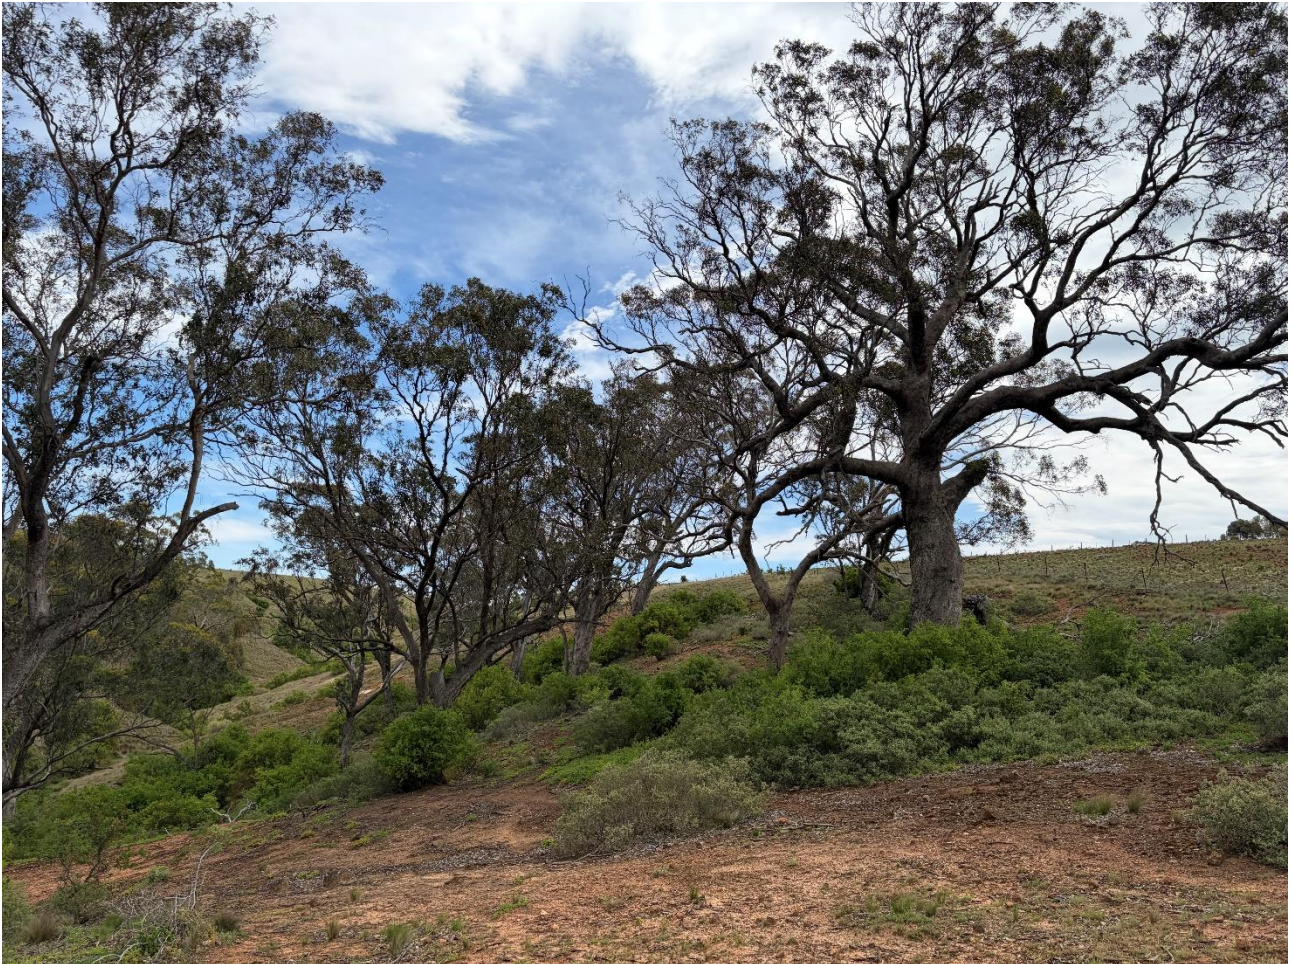
Rocky Chenopod Woodlands (Figure 4) are typically low open woodlands with trees reaching up to approximately 8 m in height. The understorey is dominated by chenopod species, with occasional grasses and seasonal herbaceous species. This EVC typically occurs on weathered clays and duplex soils with elevated salinity and low permeability, which strongly influence vegetation structure and limit water infiltration.

**Figure 4 EVC 64 Rocky Chenopod Woodland**

Examples of this EVC within the study site were characterised as a *Eucalyptus microcarpa* (Grey Box) Open Woodland (ESCAVI 2003), with a projective foliage cover of approximately 10%, and a maximum height of 12 m. The understory was dominated by the FFG Act-listed *Rhagodia parabolica* (Fragrant Saltbush, Figure 5). Other scattered chenopod shrubs observed in EVC 64 at Flanagan's Run included *Carpobrotus modestus* (Inland Pigface), *Einadia hastata* (Saloop), *Enchylaena tomentosa* var. *tomentosa* (Ruby Saltbush), *Maireana brevifolia* (Short-leaf Bluebush), *Maireana decalvans* s.s. (Black Cotton-bush), (*Sclerolaena diacantha*) Grey Copperburr, and *Sclerolaena muricata* var. *villosa* (Grey Roly-poly).

Weed cover in the ground layer was very high, and in some patches completely displaced indigenous understory plants. The dominant weeds included *Aizoon pubescens* (Galenia), *Gazania linearis* (Gazania),

*Lycium ferocissimum* (African Box-thorn), *Olea europaea* (Olive), *Mesembryanthemum cordifolium* (Heart-leaf Ice-plant), and *Physalis hederifolia* (Sticky Ground-cherry).

The vegetation observed in this EVC corresponds with the *Rocky Chenopod Open-scrub Community*, a threatened ecological community listed under the FFG Act. This community has a highly restricted distribution in Victoria, with less than approximately 200 ha estimated to remain, largely confined to sites west of Melbourne. Despite the weedy conditions within the study site, there is potential for future ecological rehabilitation and any further impacts on the vegetation should be avoided.

- Impacts on native vegetation should be avoided wherever practicable. Particular emphasis should be placed on avoiding disturbance to the patches of EVC 64 Rocky Chenopod Woodland, which correspond with the Rocky Chenopod Open-scrub Community, listed as a Threatened Ecological Community under the FFG Act.

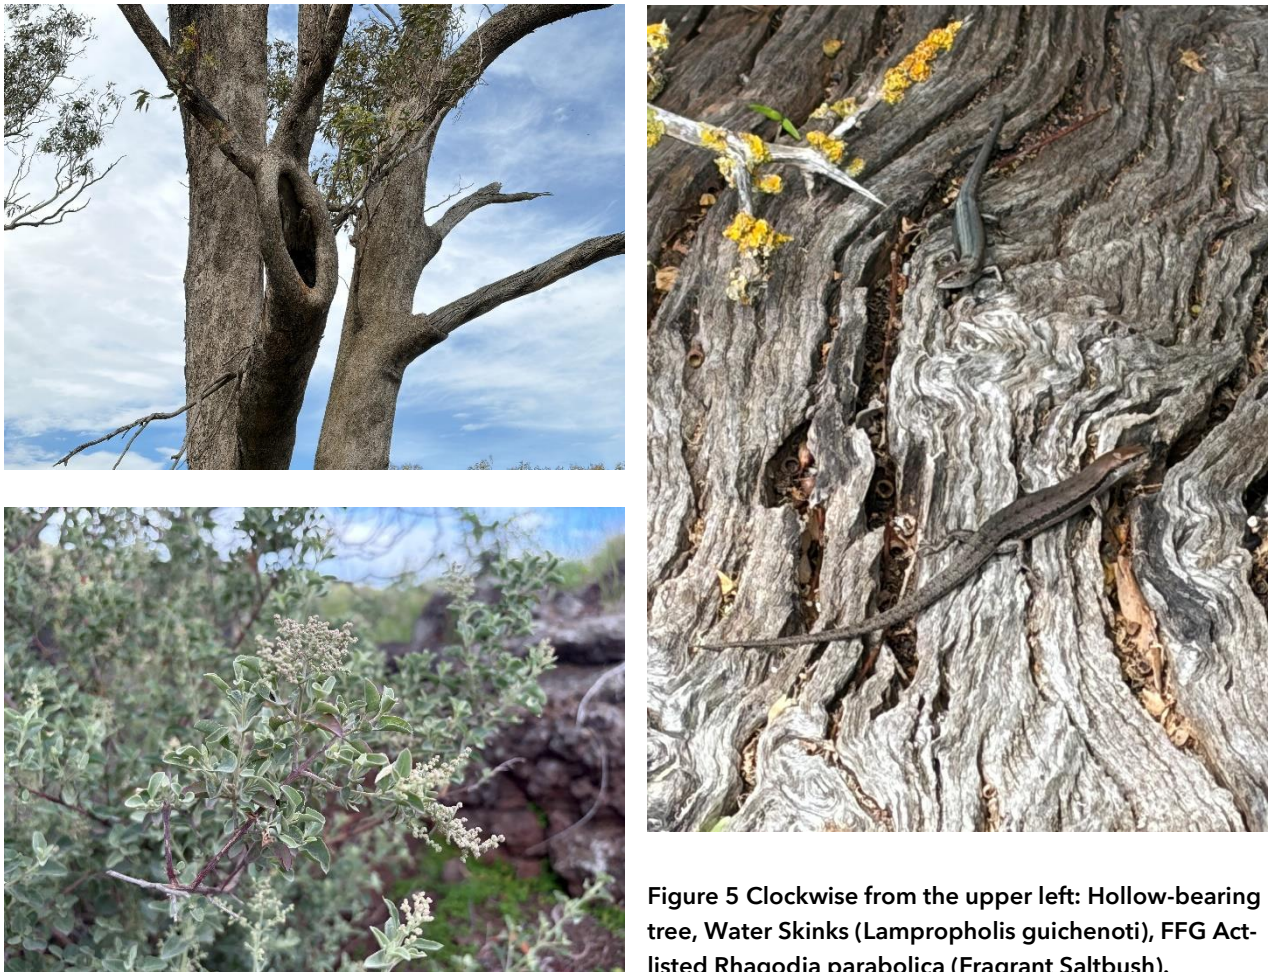
The very high numbers of hollow bearing trees (Figure 5) observed within this vegetation community could provide important habitat for fauna species, including several threatened taxa such as the Brush-tailed Phascogale (*Phascogale tapoatafa tapoatafa*) and Powerful Owl (*Ninox strenua*). The vegetation could also provide important habitat for woodland birds, including the threatened Speckled Warbler (*Pyrholaemus sagittatus*) and Diamond Firetail (*Stagonopleura guttata*), which have been previously recorded at the nearby Long Forest Flora and Fauna Reserve. The prevalence of fallen logs and dense shrubs could also provide habitat for ground-dwelling reptiles and mammals, such as the incidentally observed Water Skink (*Lampropholis guichenoti*) (Figure 5).

Figure 5 Clockwise from the upper left: Hollow-bearing tree, Water Skinks (*Lampropholis guichenoti*), FFG Act-listed *Rhagodia parabolica* (Fragrant Saltbush).

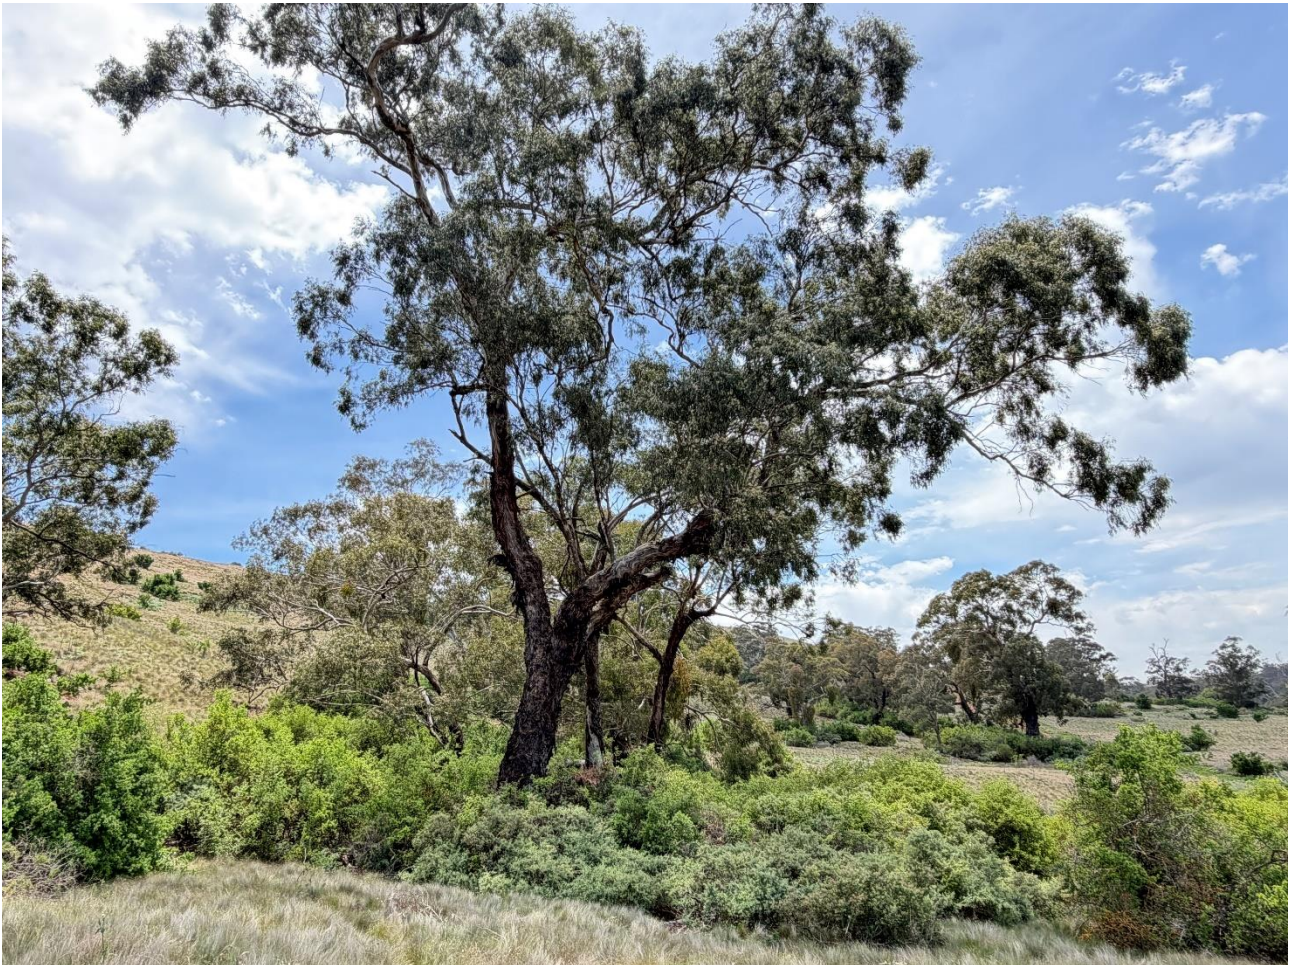
EVC 175 Grassy Woodland (Figure 6) typically refers to variable open woodlands, dominated by eucalypt species reaching up to approximately 15 m in height, or occasionally by *Allocasuarina* (Sheoak) and *Acacia* species forming a lower woodland to around 10 m. The understorey is characterised by a diverse and often species-rich ground layer of native grasses and forbs, while the shrub layer is generally sparse or absent. This EVC occurs on sites of moderate soil fertility, typically on gentle slopes or undulating hills, and is associated with a range of underlying geological substrates.

**Figure 6 EVC 175 Grassy Woodland within the study site**

Within the Flanagan's Run site EVC 175 Grassy Woodland was an Open Woodland (ESCAVI 2003) occupying the escarpments and lower slopes in the eastern portion of the study site. The observed patches of EVC 175 were characterised by a canopy layer of large *Eucalyptus melliodora* (Yellow Box) up to 14 m tall, with a projective foliage cover of approximately 15%. The ground layer has suffered from significant weed invasion and the only commonly occurring remnant native species was *Rhagodia parabolica* (Fragrant Saltbush). The dominant noxious weeds included *Lycium ferocissimum* (African Box-thorn) and *Nassella trichotoma* (Serrated Tussock).

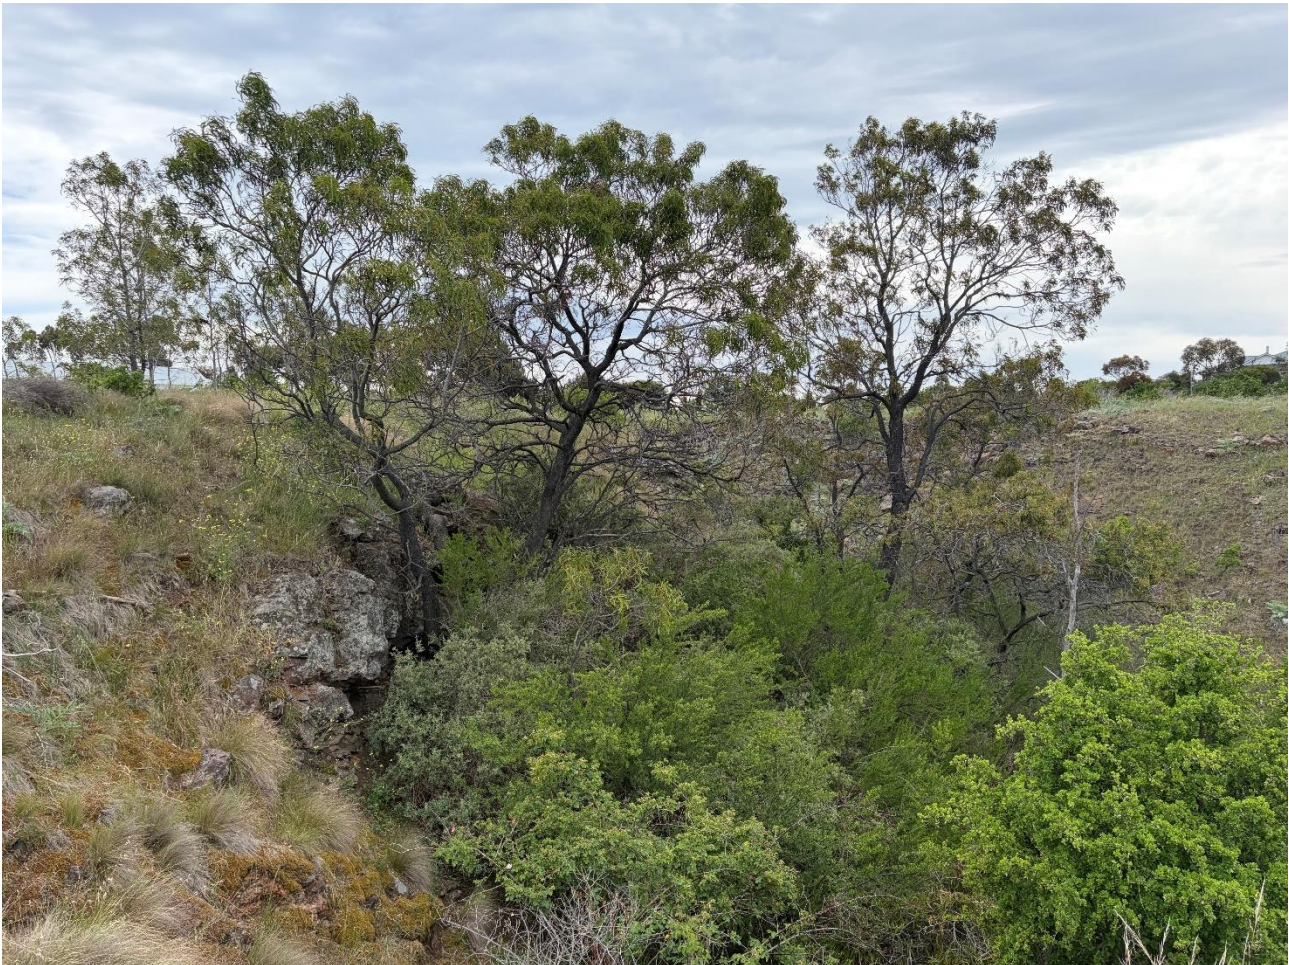
EVC 895 Escarpment Shrubland (Figure 7) occurs on rocky escarpments within steep valleys and gorges, typically associated with limestone or basalt substrates. Sites are generally well-drained and of moderate to high fertility but are subject to regular summer moisture stress due to shallow soil profiles. Vegetation structure can be variable, comprising either open eucalypt woodland up to approximately 15 m tall or non-eucalypt shrubland to around 8 m tall with occasional emergent eucalypts. Exposed, lichen-covered rock outcrops are a common and characteristic feature of this EVC.

**Figure 7 EVC 895 Escarpment Shrubland within the study site**

Within the study site, this EVC occurred in a few small sections of the waterway where the suitable geomorphic conditions were present. The vegetation in these patches was an *Acacia implexa* (Lightwood) and *Melicytus dentatus* (Tree Violet) Open Shrubland (ESCAVI 2003), with a maximum height of 4 m and a projective foliage cover of 15%. The patches of this EVC were unique in the context of the study site for having a more intact ground layer with several grass and forb species still present. These included species such as *Chloris truncata* (Windmill Grass), *Convolvulus angustissimus* subsp. *omnigracilis* (Slender Bindweed), *Dichanthium sericeum* subsp. *sericeum* (Silky Blue-grass), *Erodium crinitum* (Blue Heron's Bill), *Hackelia suaveolens* (Sweet Hound's-tongue), *Geranium gardneri* (Rough Crane's-bill), *Wahlenbergia capillaris* s.s. (Tufted Bluebell), *Rytidosperma setaceum* var. *setaceum* (Bristly Wallaby-grass), and *Themeda triandra* (Kangaroo Grass). The floristic composition observed in these locations indicates that

Weed cover within patches of EVC 895 was moderate, and included *Aizoon pubescens* (Galenia), *Lycium ferocissimum* (African Box-thorn) and *Nassella trichotoma* (Serrated Tussock).

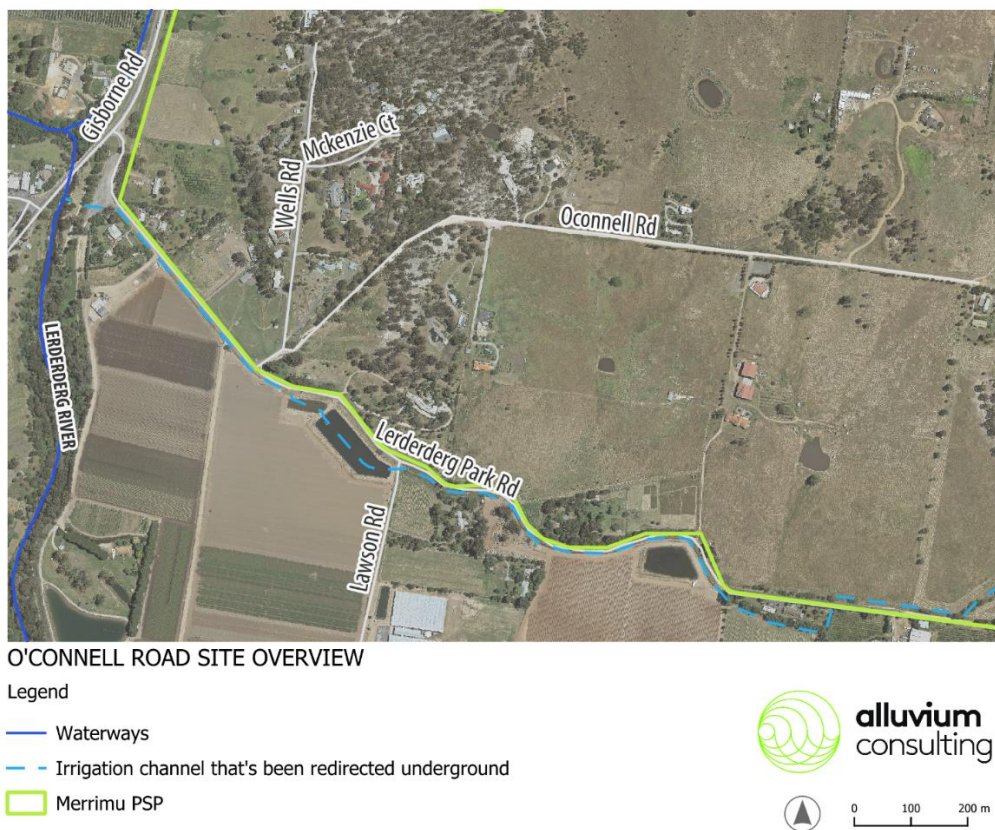
Since Alluvium's geomorphic assessment of the region in 2019, the irrigation channel that was a tributary of Lerderderg River that previously flowed adjacent to Lerderderg Park Road has been redirected underground and is no longer a surface waterway. Therefore, the closest surface waterway for local stormwater outfall from O'Connell Road is the Lerderberg River to the west of O'Connell Road. The desktop and visual assessment found no particular pathways between O'Connell Road and the Lerderderg River that should be avoided for geomorphic reasons.

**Figure 8. Configuration of O'Connell Road with respect to the River Lerderberg and irrigation channel that has been redirected underground.**

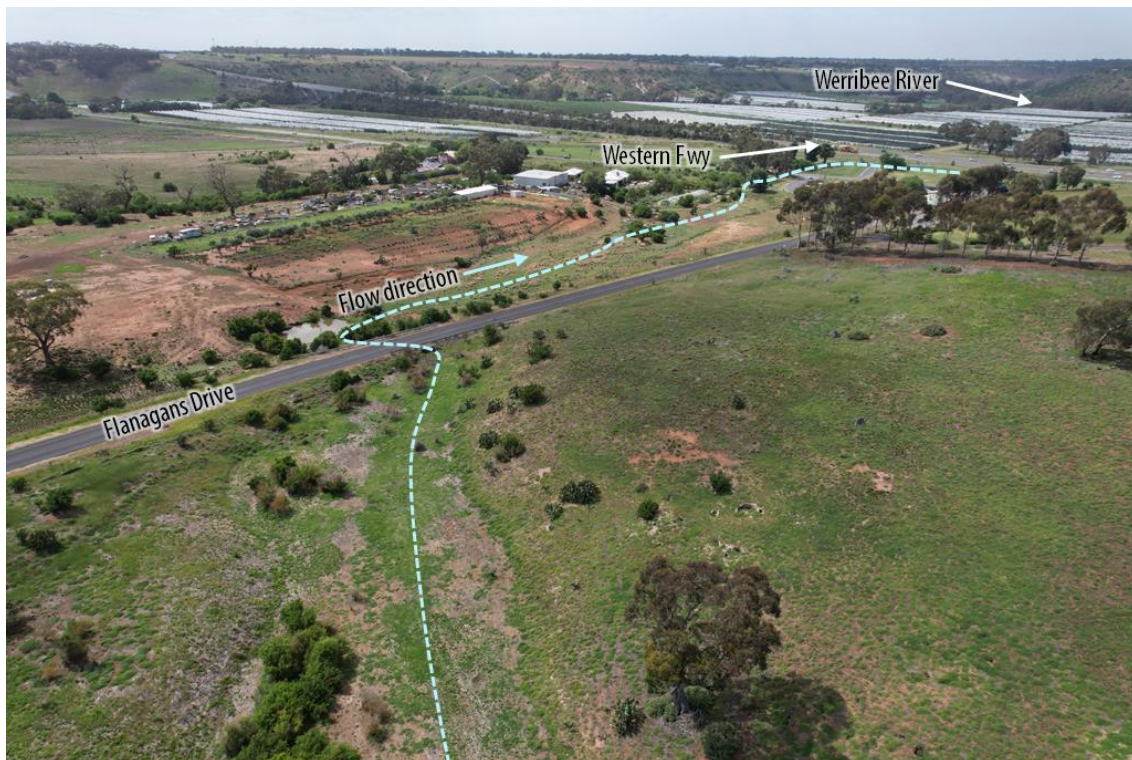
After flowing off the escarpment, the creek continues south, passing through culverts beneath Flanagan's Drive. Here, the creek's flow is interrupted by a series of small farm dams before continuing through culverts under Bacchus Marsh Road, and subsequently, the Western Freeway (Figure 10). Once the waterway flows under the freeway, the path it takes to reach Pyrites Creek and, ultimately, the Werribee River is unclear and was not observable from the roadside or via drone imagery (Figure 11).

Figure 10. Looking south-southwest, a view of the Flanagans run assessment area's main tributary crossing under Flanagans Drive, through farm dams and agricultural lands, towards the Western Freeway, where it's path to the Werribee River becomes unknown.

- Further hydraulic assessment is required south of Flanagan's Drive to define the preferred outfall alignment and receiving location. This should include basic hydraulic modelling to delineate flow paths, confirm culvert capacity, assess whether new or upgraded channels or pipes are required, define the dimensions of any required conveyance works, and assess erosive forces under peak flow events relative to existing conditions.

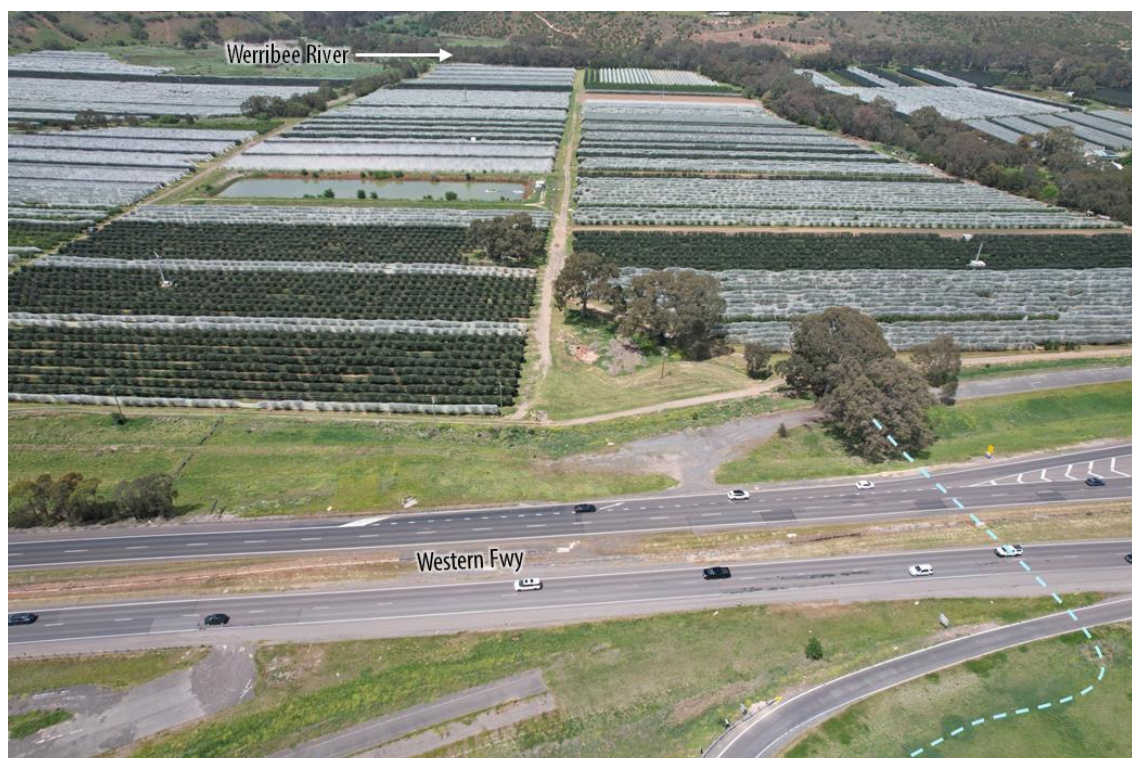
The area has been heavily modified by both freeway construction and associated earthworks. Although the exact waterway alignment is unclear at this point, the waterway is mapped (and does appear) to pass under the Western Freeway, where it meets then flows across an intensively cropped section of the Pyrites Creek floodplain. No defined channel is evident in this section of the cropped floodplain, with the exception of what appears to be a linear drain that may convey flows towards a road within the floodplain. This channel is not distinguishable in LiDAR datasets and it is unclear whether it does convey any flows from the plateau towards Pyrites Creek. Any such flows may be lost to infiltration between the plateau escarpment and the freeway, or soon afterwards within the cropped section south of the freeway.

Figure 11. Looking south, a view of the Flanagans Run assessment area's main tributary crossing under the Western Freeway. The tributary's flow pathway to the Werribee River is currently unknown.

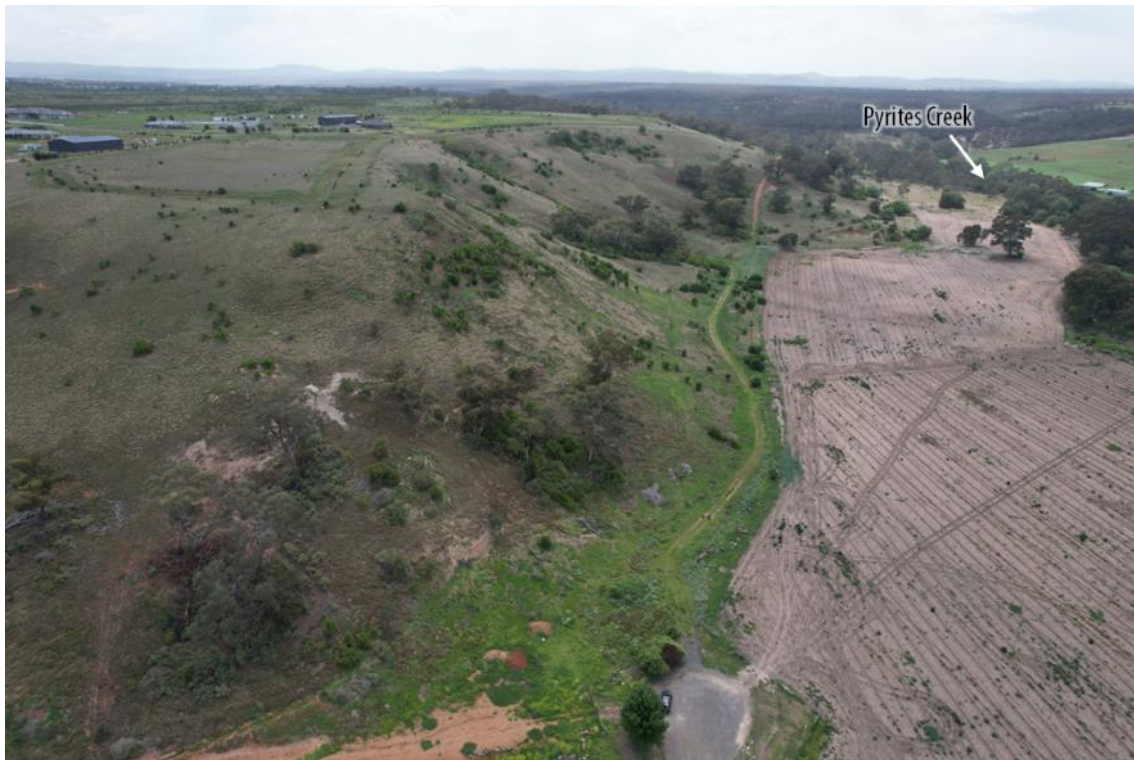
The southeastern edge of the escarpment that runs parallel to Pyrites Creek has several gullies that have formed along the steep slopes of the plateau's edge (Figure 12). Sodic soils were observed within these gullies and exposed on the steep slopes of the escarpment (Figure 13).

Figure 12. Looking north, a view of the eastern side of the escarpment plateau running parallel to Pyrites Creek to the east.

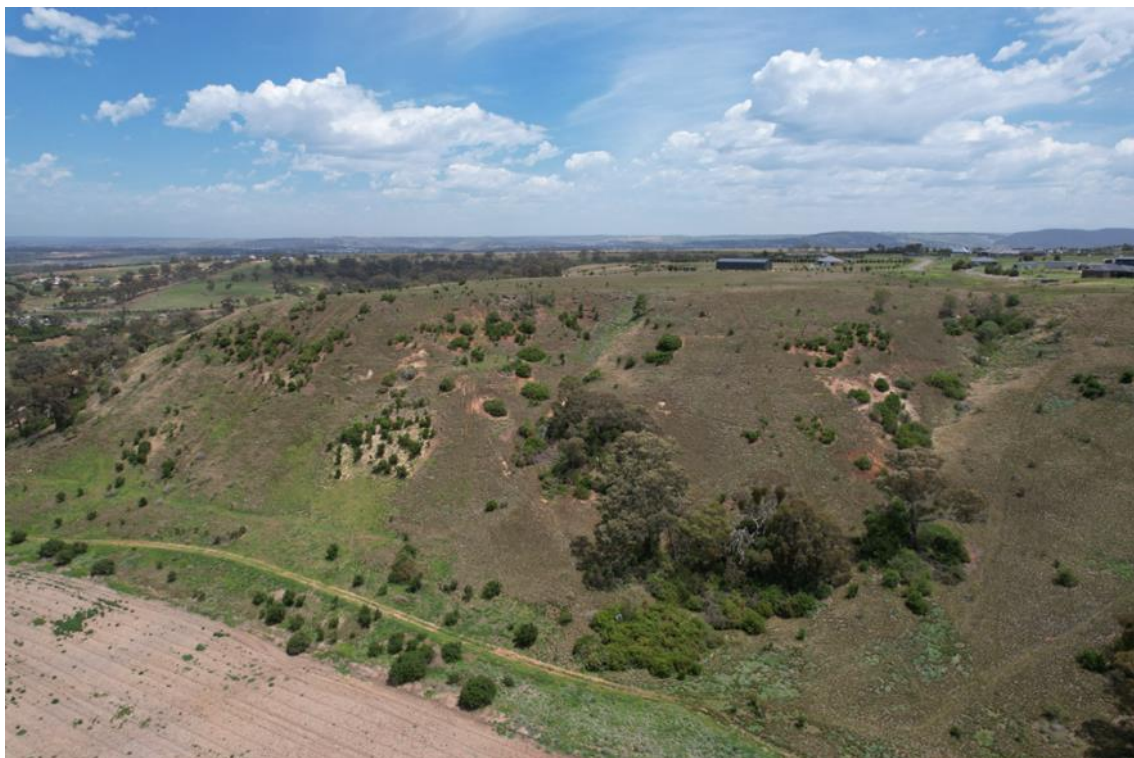
Figure 13. Looking west, a view of gullies on the eastern side of the escarpment.
