# Croskell PSP Proposed Drainage Strategy

## Geotechnical site report – additional investigation

Prepared for Melbourne Water

Prepared by Water4Good

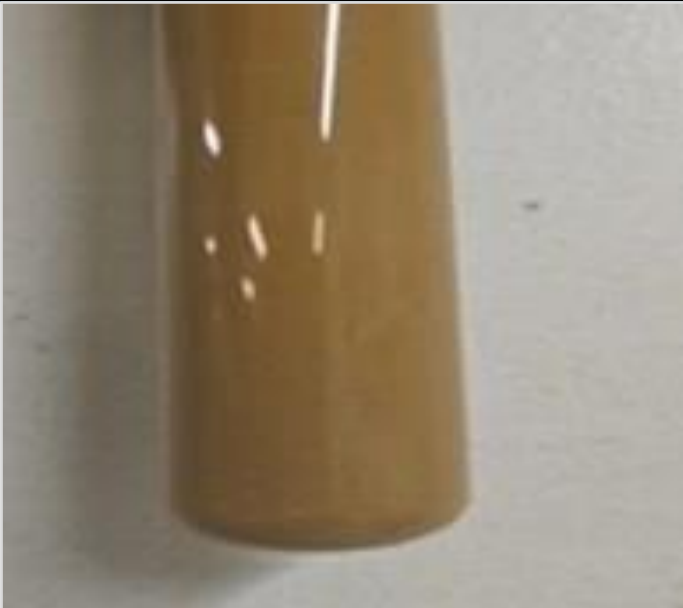
| | <div>Emerson class number</div> <div><b>Class 5</b></div> |

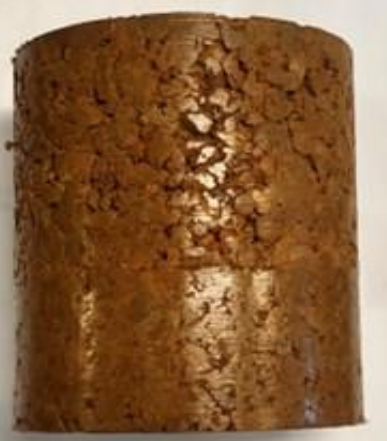
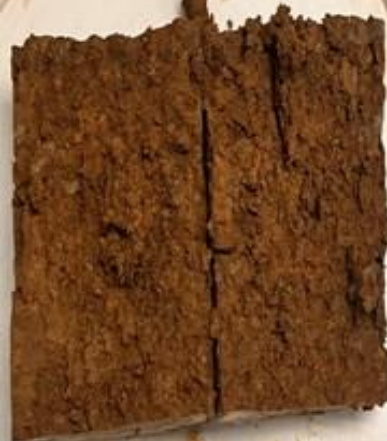
## Post-test photo

| | | Permeability: (m/s) | 1E-10 |

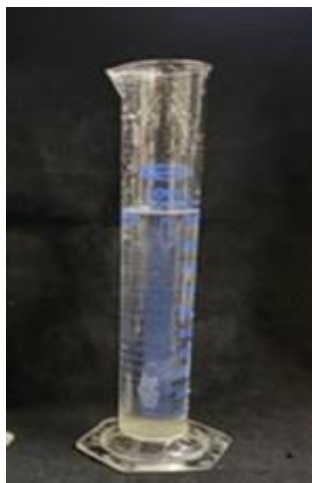
| <p>Sample type: Remoulded</p> <p>Curing time: &gt;48 hours</p> <p>Date prepared: 16/09/2024</p> <p>Date Tested: 20/09/2024</p> <p>Target dry density (t/m<sup>3</sup>): 1.49</p> <p>Initial moisture content: 26.7%</p> <p>Remoulded moisture content: As received</p> <p>Remoulded moisture content: 26.5%</p> <p>Remoulded density (t/m<sup>3</sup>): 1.88</p> <p>Remoulded dry density (t/m<sup>3</sup>): 1.49</p> <p>Moisture content calculation is performed in accordance with AS AS 1289.2.1.1 - 2005</p> | <p>Photo post test - Final cylinder</p> |
| <p>Specimen history /Notes: Sample remoulded to target of 95% of SMDD at 100% OMC. Compaction data; SMDD = 1.57 t/m3, OMC = 26 %.</p> | |
